Evaluating Stream Restoration Projects in the Sprague River Basin

Prepared for:

Klamath Watershed Partnership, in conjunction with the Klamath Tribes, the U.S. Fish and Wildlife Service, the Klamath Basin Rangeland Trust, Sustainable Northwest, and The Nature Conservancy

NewFields River Basin Services & Dr. G. M. Kondolf

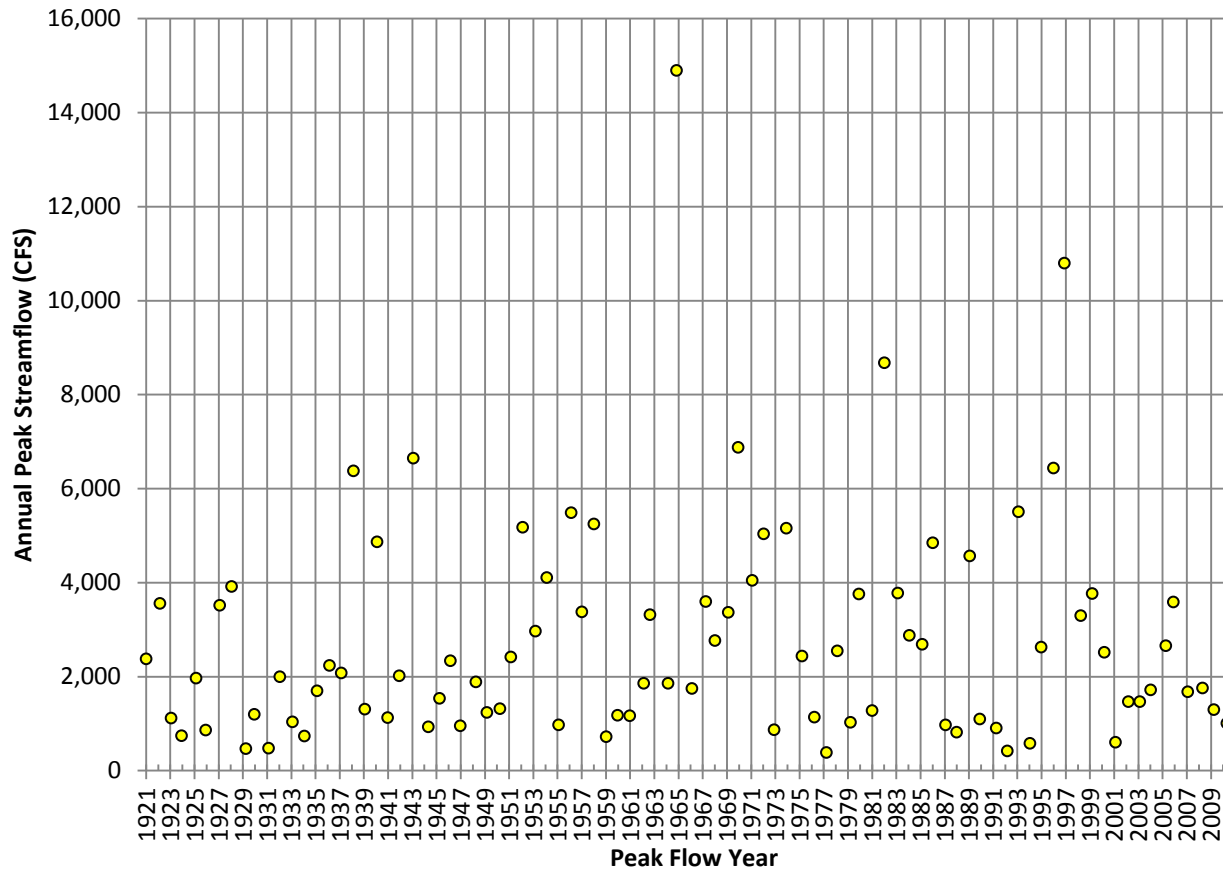
Figure 2.3-1: Annual peak flows for USGS 11501000 Sprague River at Chiloquin, 1921 – 2010 (Source: USGS 2012 <http://waterdata.usgs.gov/nwis>)

Error! Reference source not found. shows annual peak flows for the Sprague River at Chiloquin (USGS Gage 11501000). We were especially interested in peak flow hydrology over the past ten to fifteen years as all of the stream restoration projects we evaluated were completed during this period and influenced by the hydrology of the time. In general, compared to previous decades, the last decade has experienced lower magnitude peak flows. The three largest peak flows in the last decade include 3,590 cfs (on Jan 5th, 2006), 2,660 cfs (on May 23rd, 2005), and 2,520 cfs (on April 23rd, 2000). In contrast, the decades beginning in 1970, 1980, and 1990 each had at least three years where flows exceeded 4,000 cfs (USGS 2012).

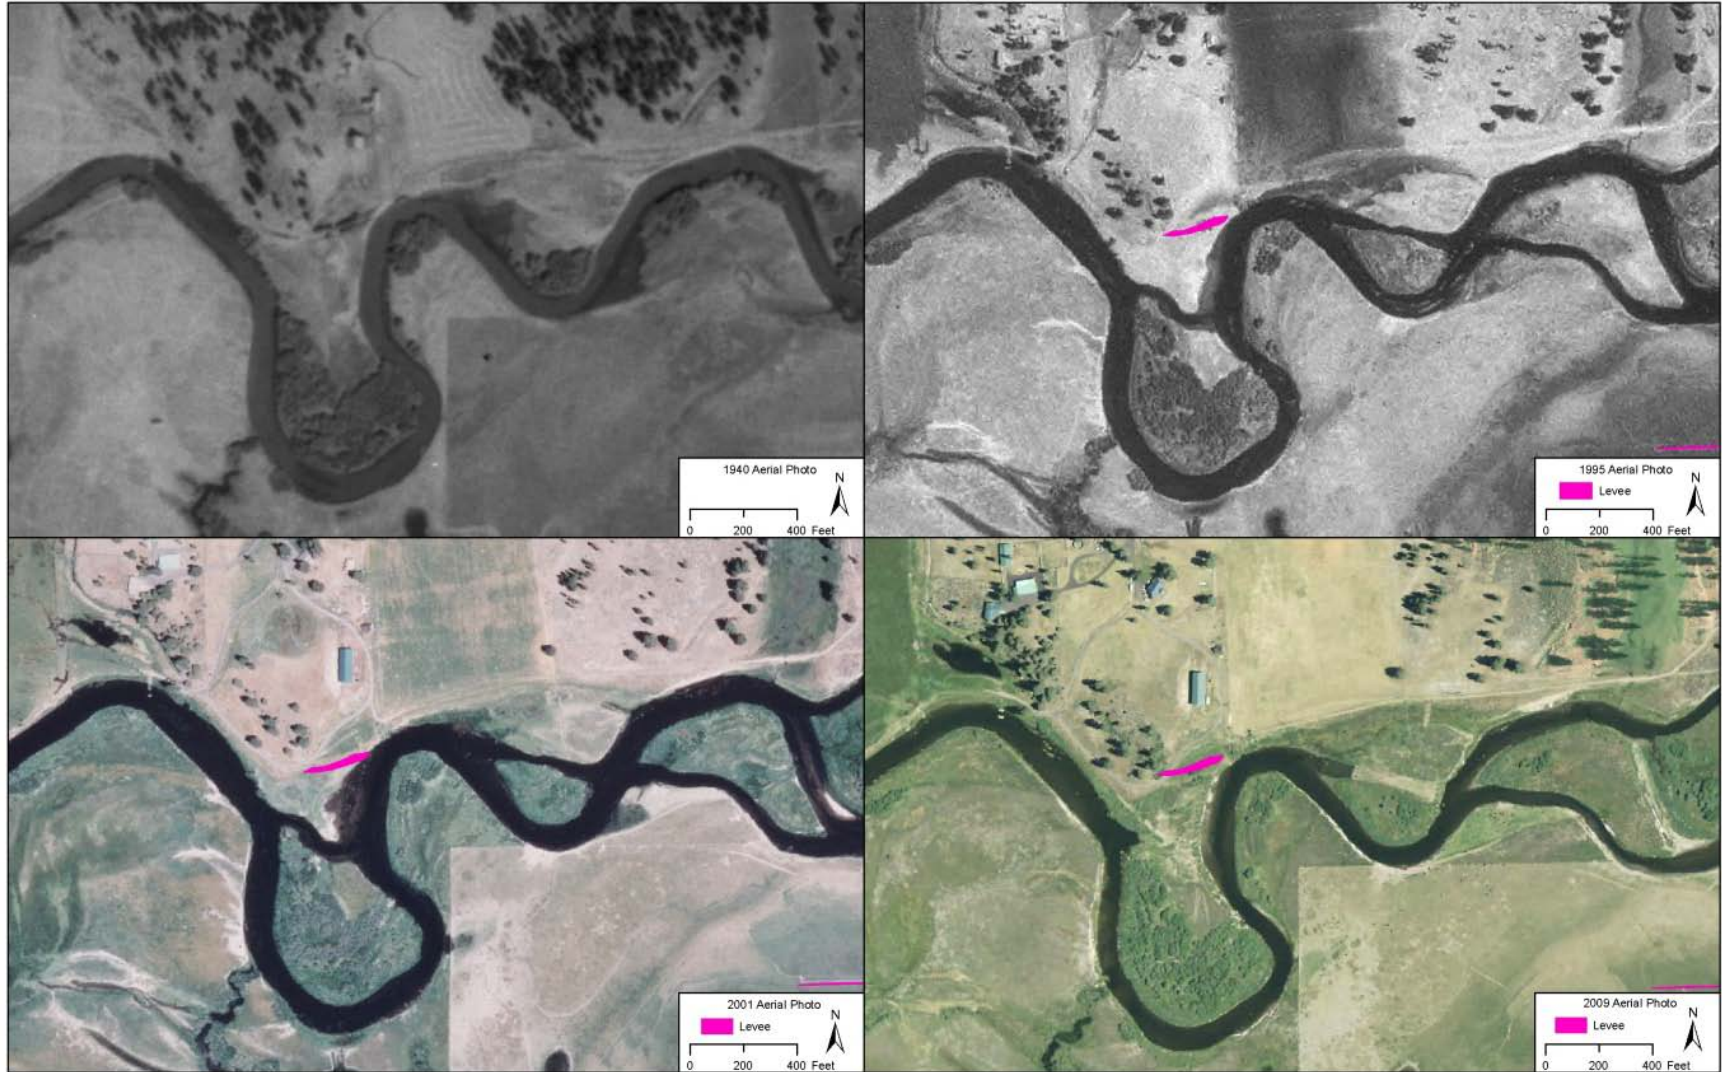
Figure 6.1-3: Historical aerial photograph sequence of the project reach from 1940, 1995, 2001, and 2009 showing development and persistence of meander cutoffs and implementation of meander cutoff plugs.

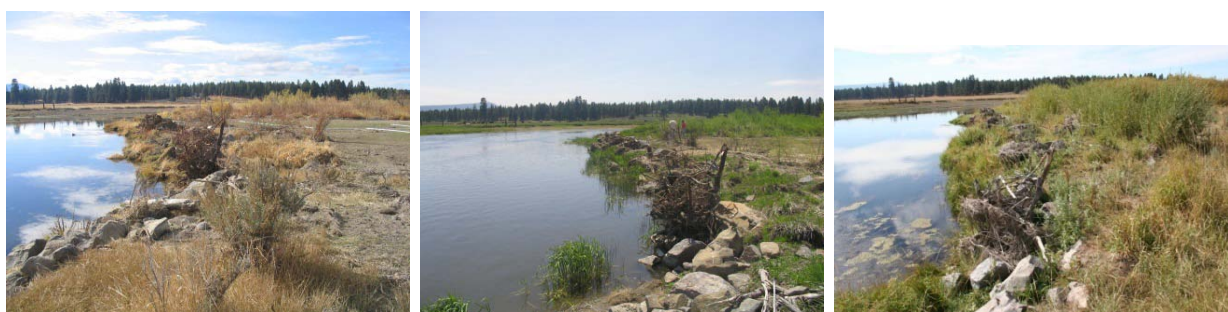
Figure 6.1-4: Looking southeast (downstream) from upstream end of meander cutoff plug at site 8 in 2006, 2007, and 2011 (from left to right) showing stability of meander plug and recruitment and growth of willows and other vegetation.

Figure 6.1-4 and Figure 6.1-5 are historical ground photo series of the upstream faces of meander cutoff plugs eight and nine, respectively. Both photo series clearly show the stability of the upstream end of the bioengineered plug and the establishment of willows and other vegetation on the plug surface. Based on this photo monitoring, the plug appears to have performed as described in the project success criteria over the first six years since it was installed.

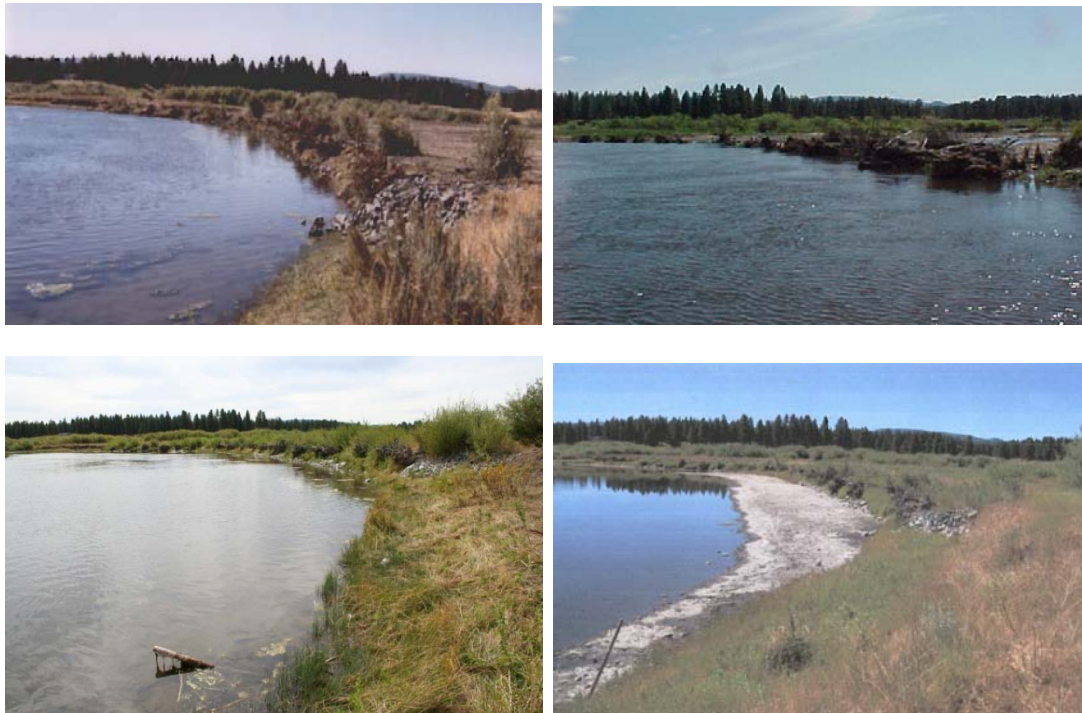
Figure 6.1-5: Looking southeast (downstream) from upstream end of meander cutoff plug at site 9 in 2005, 2006, 2008 and 2011 (clockwise from upper left) showing installation of meander plug, meander plug inundation during spring high flows, and recruitment and growth of willows and other vegetation increasing the stability and structure of the meander plug.

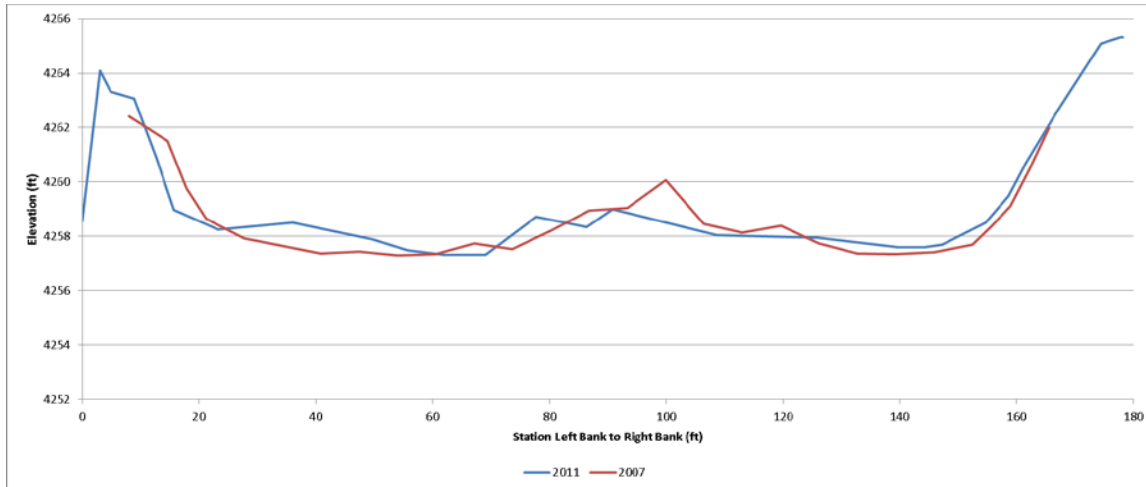
Figure 6.1-6: Channel geometry in 2007 and 2011 at cross section number one (location shown in Figure 6.1-2)

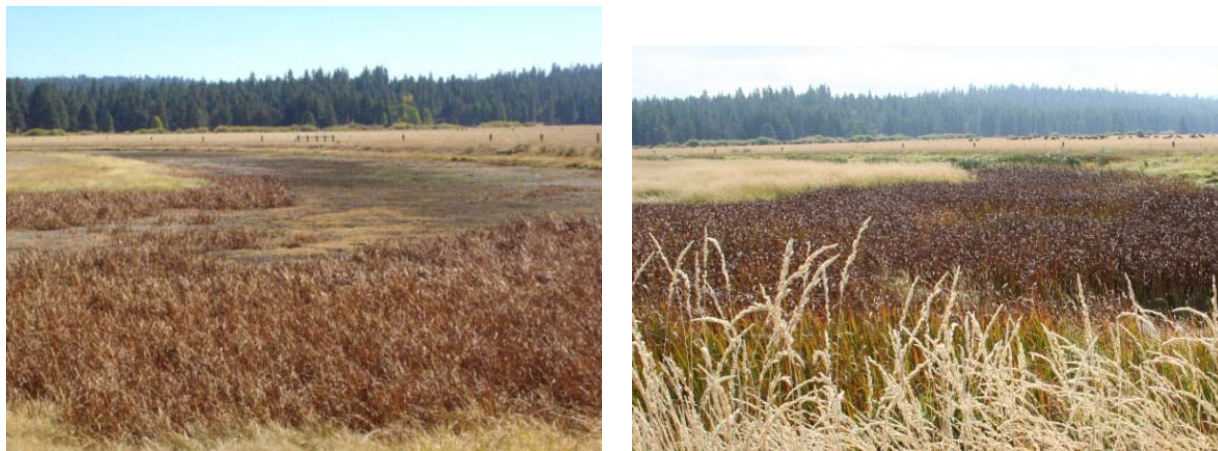
Figure 6.2-4: Looking southeast into the western arm of wetland 1 in 2005 and 2011 showing increased coverage of both wetland and upland vegetation in and adjacent to the floodplain wetlands.

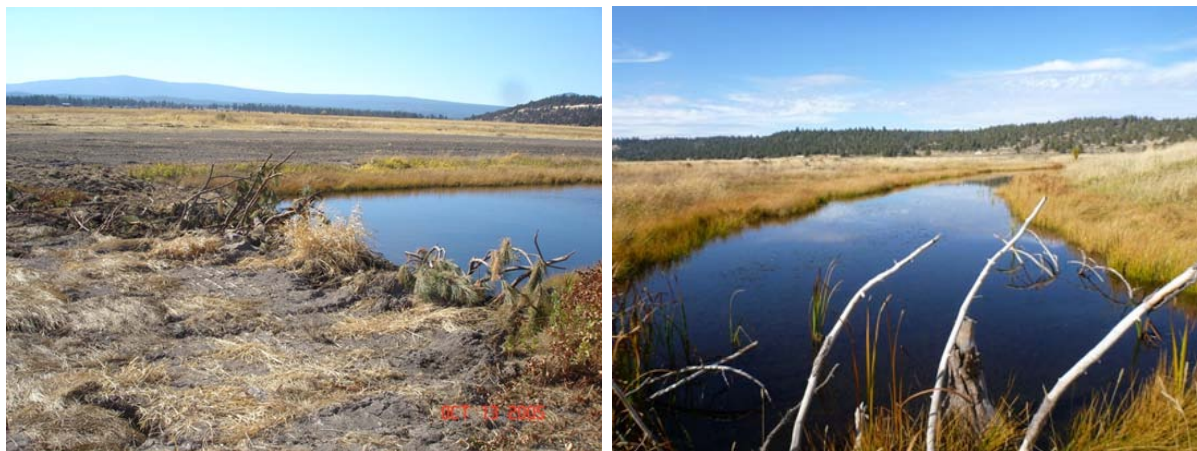
Figure 6.3-6: Conditions in 2005 showing the as-built condition from the tail of the channel plug (left image). Photograph taken from the downstream extent of the channel plug in 2011 (right image). Comparison of the photographs shows an increase in grass and rushes, but no increase in woody vegetation.

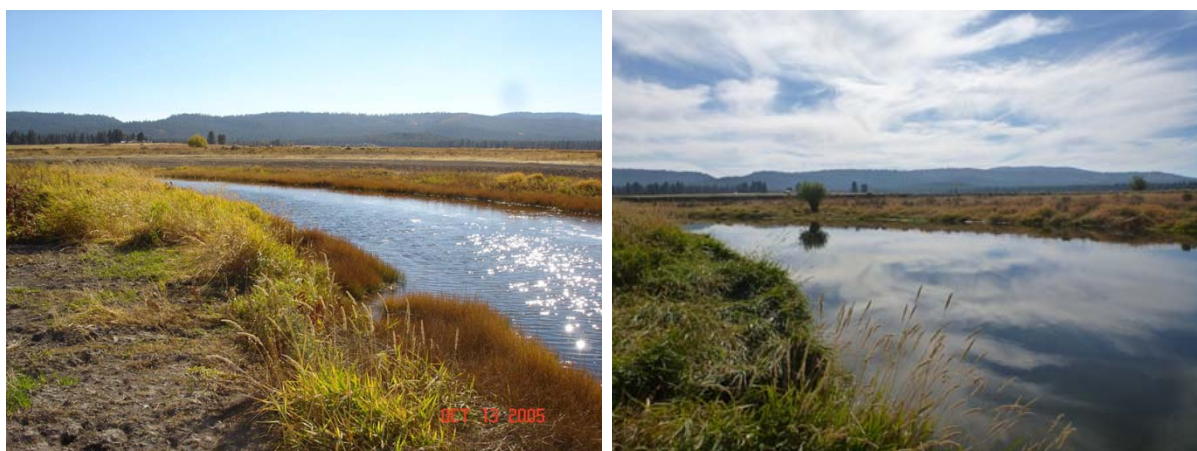
Figure 6.3-7: Conditions in 2005 showing the as-built condition of the channel banks and floodplain looking south from the bank opposite of the channel plug (left image). The same location in 2011 (right image). Comparison of the photographs shows an increase in grass and rushes and limited increase in woody vegetation.

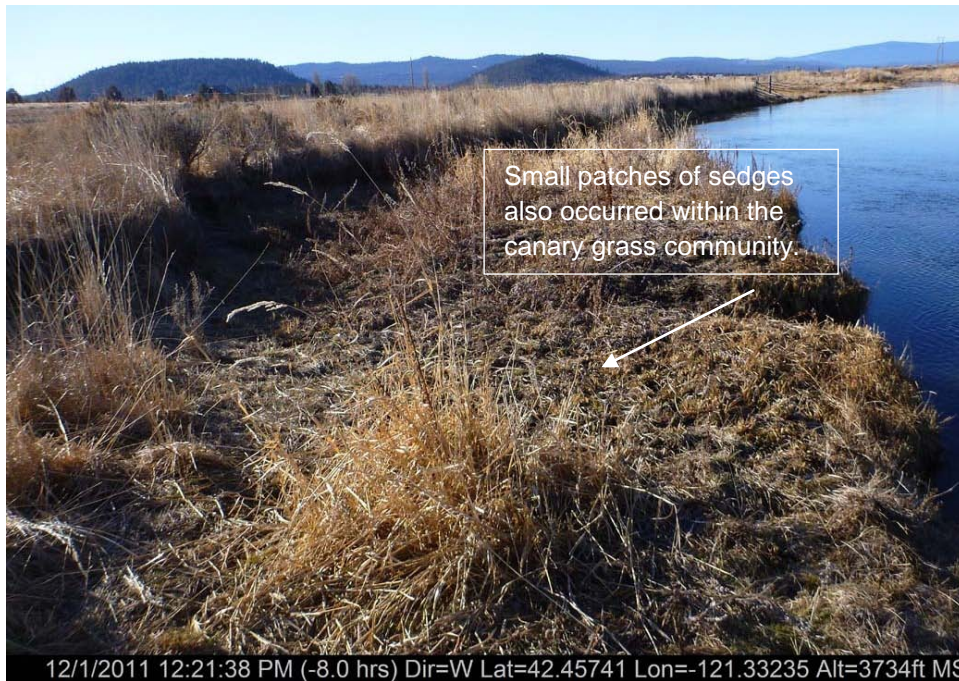
Figure 6.4-3: Photo showing the sage and meadow foxtail grass community on the upper bench, with a small patch of reed canary grass (indicated by arrow) among annuals and grazed sedges and grasses on the lower bench.

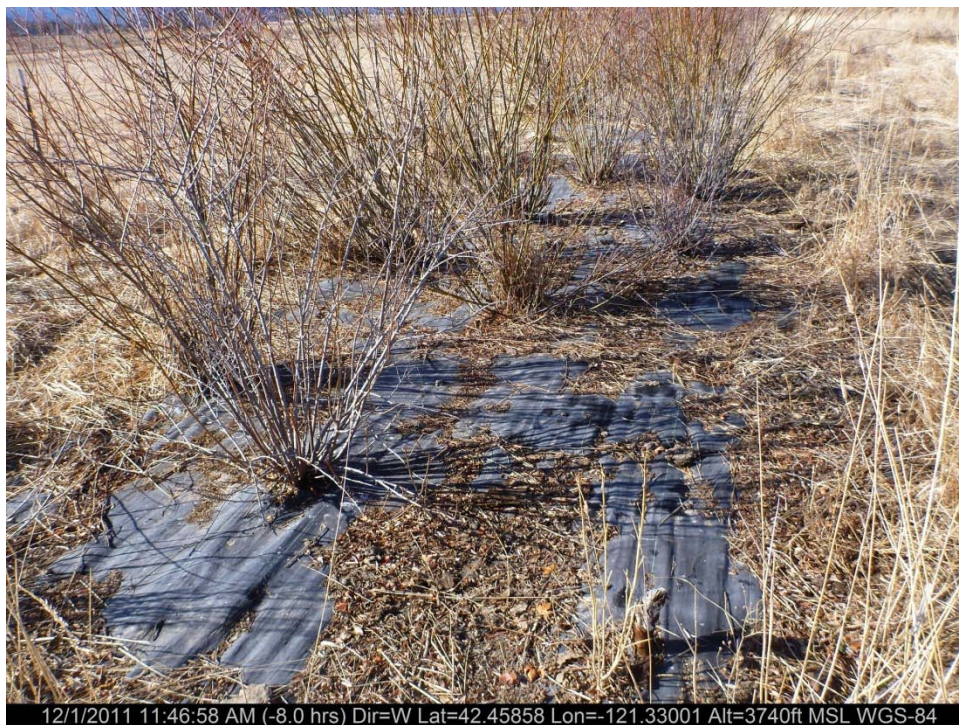
Figure 6.4-4: Photo showing willow planting with weed barrier in the CREP easement area.

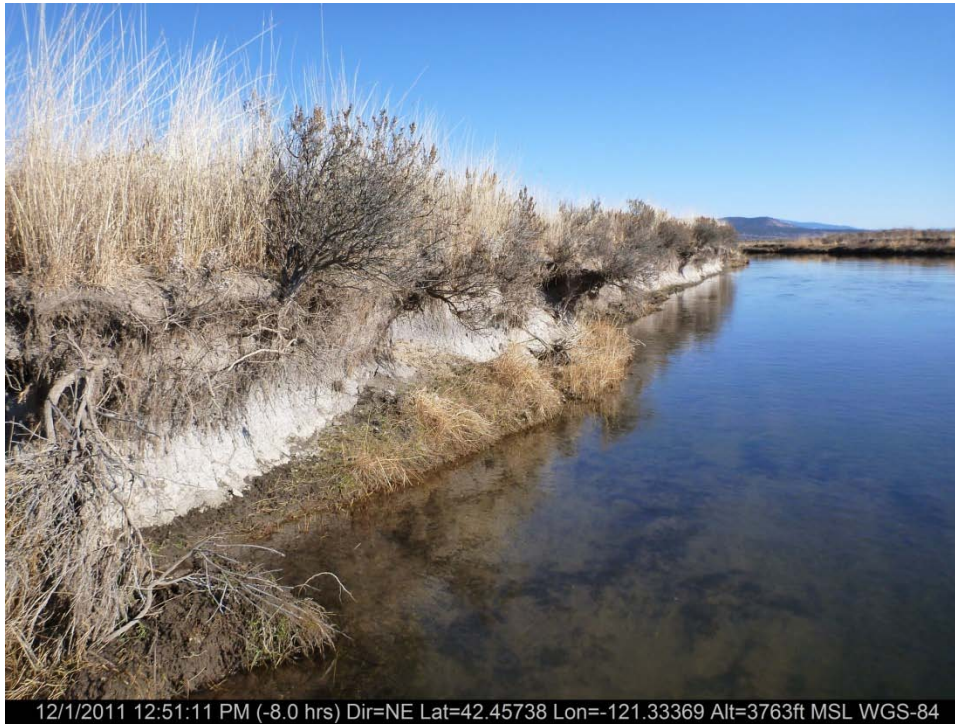
Figure 6.4-5: Photo showing a cut bank with sage and meadow foxtail grass community on the top of bank, and rushes on a lower ledge at the edge of water.

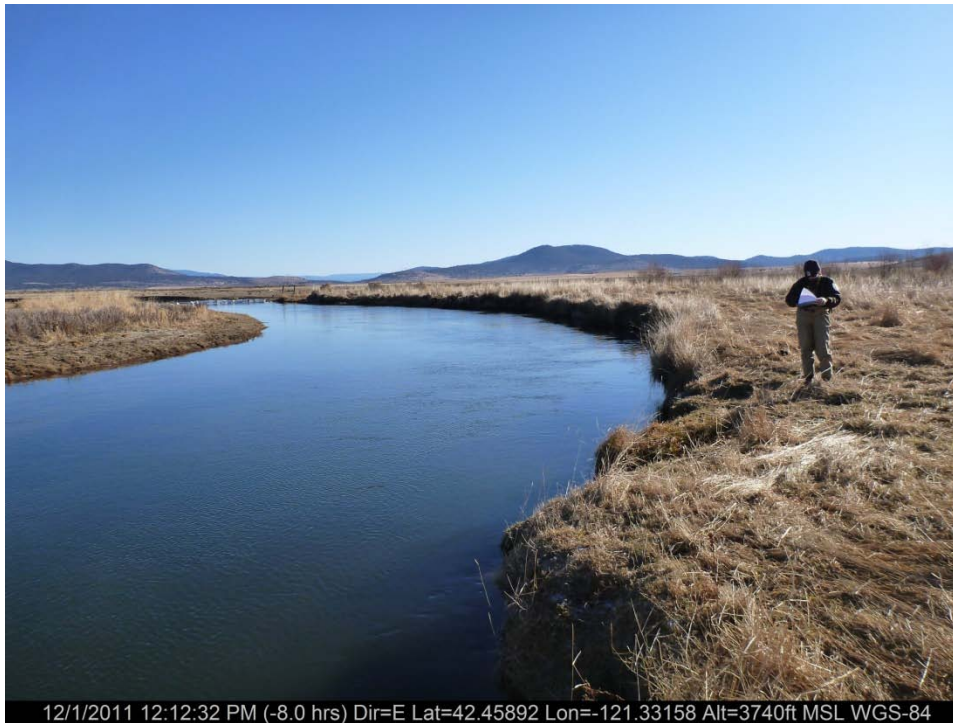
Figure 6.4-8: Bank erosion on an outside bend of the channel and deposition on a point bar on the inside of the bend.

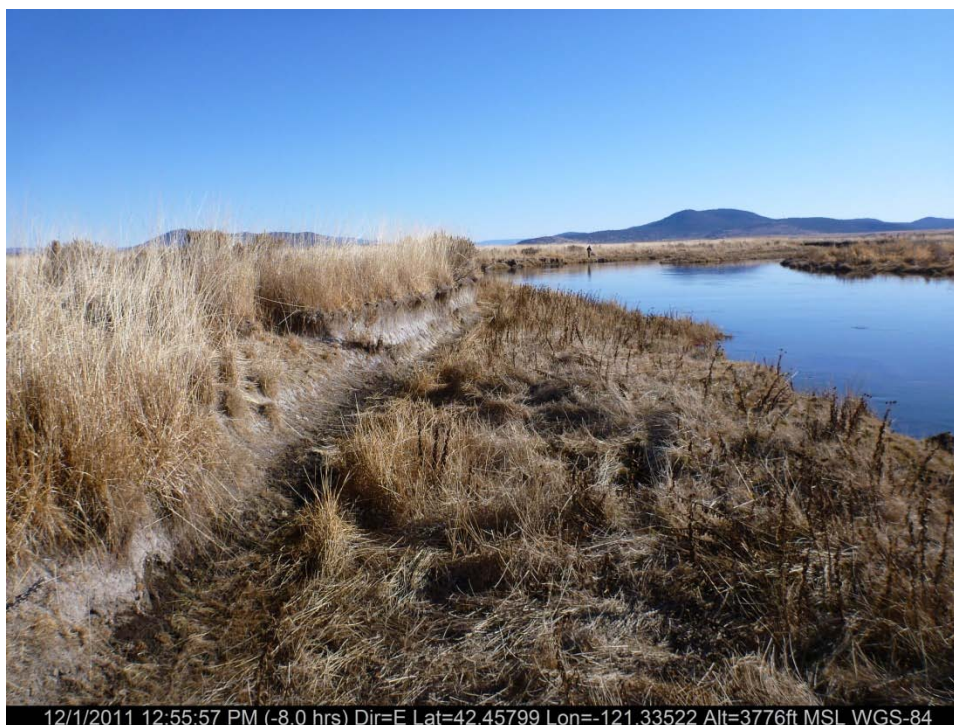
Figure 6.4-9: Bank erosion where eroded material has formed a lower surface that has been colonized by grasses and forbs.

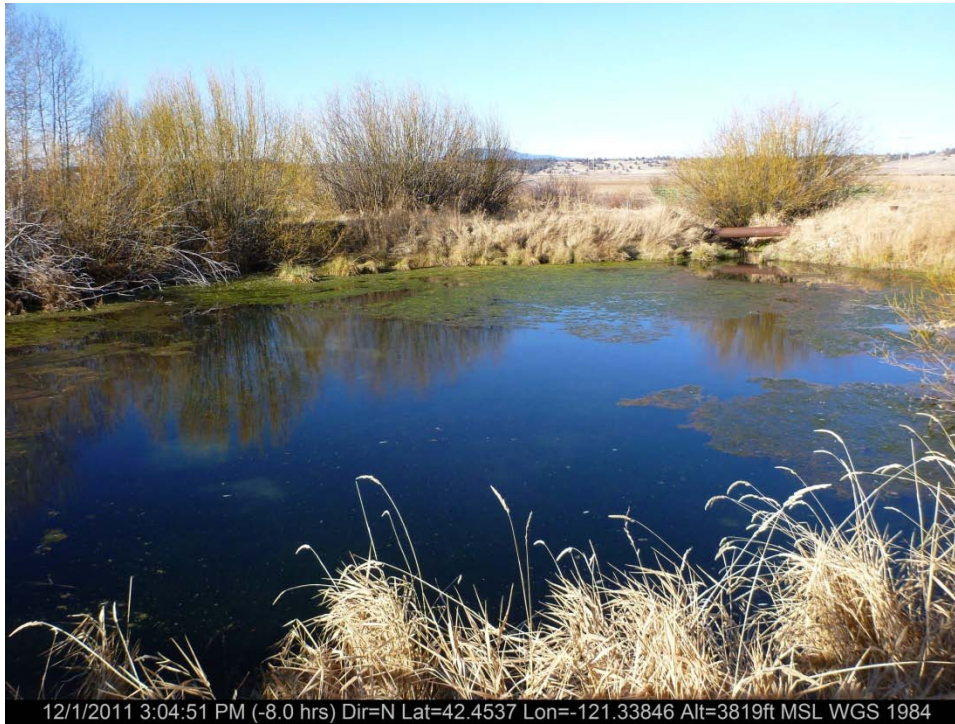
Figure 6.4-10: Photograph showing fenced spring. The water is clear and mature riparian vegetation borders the spring.

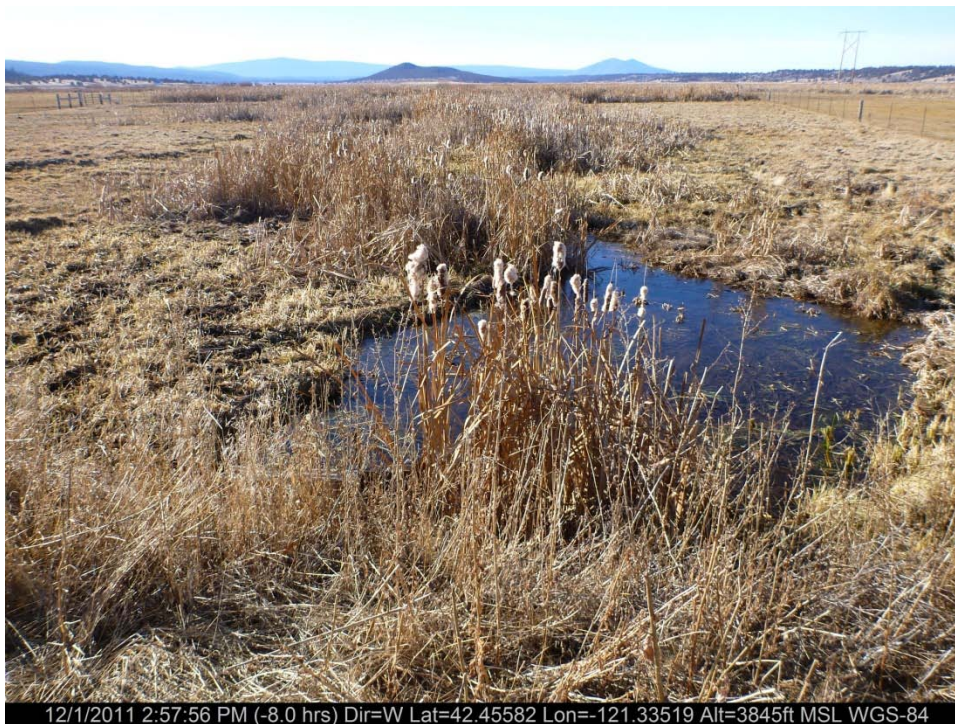
Figure 6.4-11: Photograph taken from the levee looking up the channel towards the spring. Tules are shown blocking the channel upstream of the culvert.

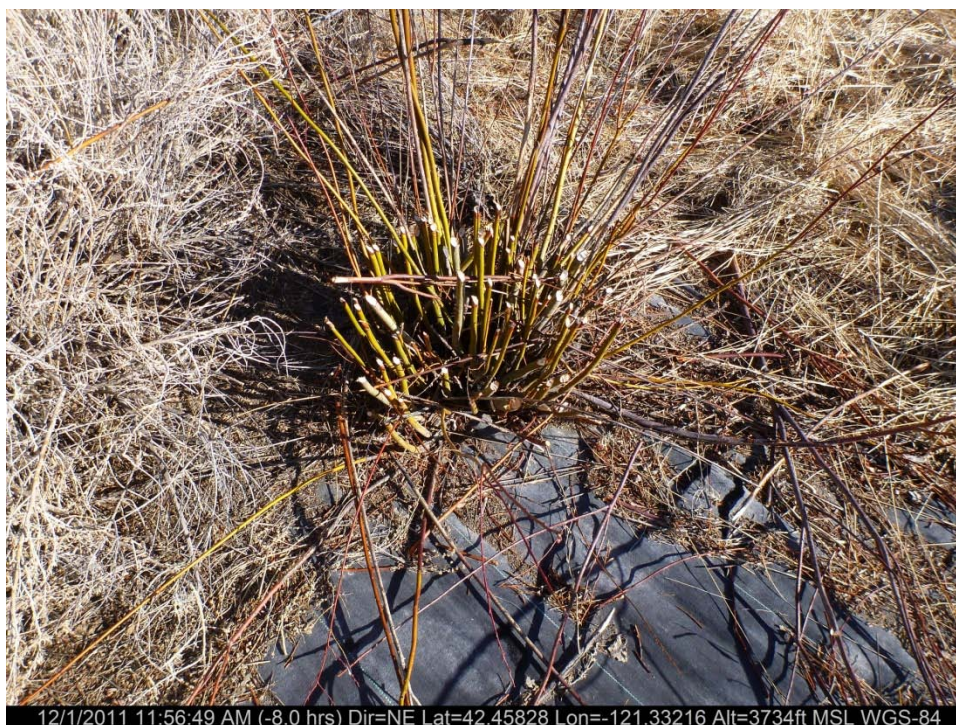
Figure 6.4-12: NRCS planted willow in the fenced riparian with about 50% of the branches removed by beaver.

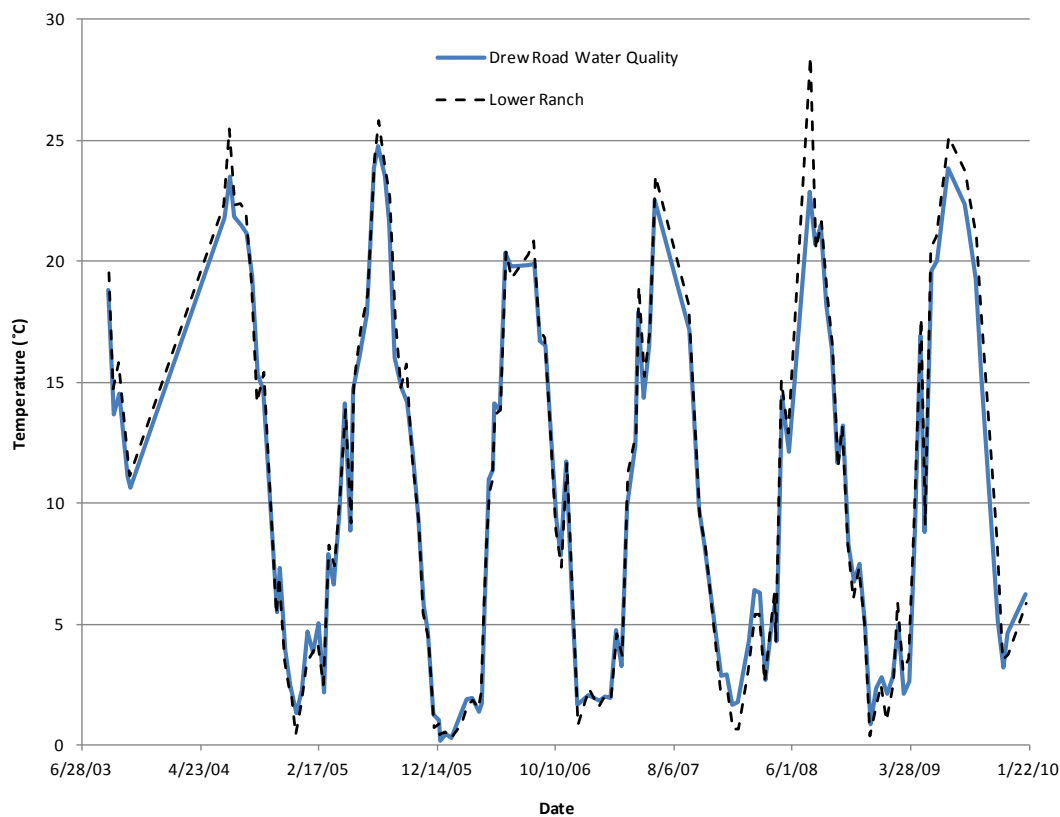
Figure 6.5-4: Temperature comparison between the Dews Road water quality sampling location and the lower ranch temperature monitoring location.

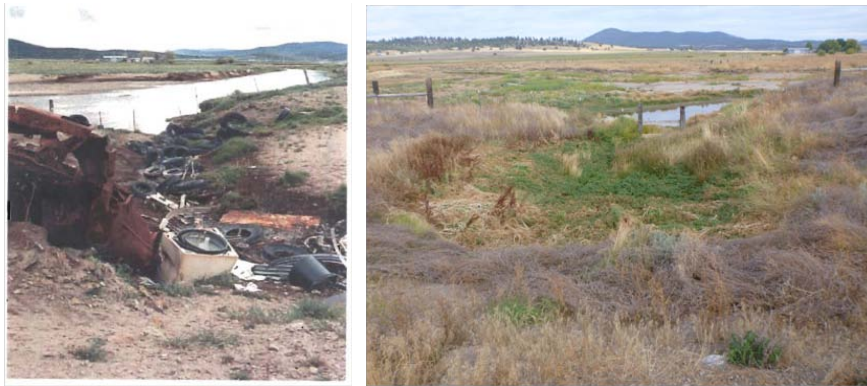
Figure 6.5-5: Conditions in 2001/2002 showing the pre-project condition of the Old Tire Spring (left image). The same spring in 2011 (right image). Comparison of the photographs shows an increase in vegetation and decrease in trash. Both changes improve water quality.

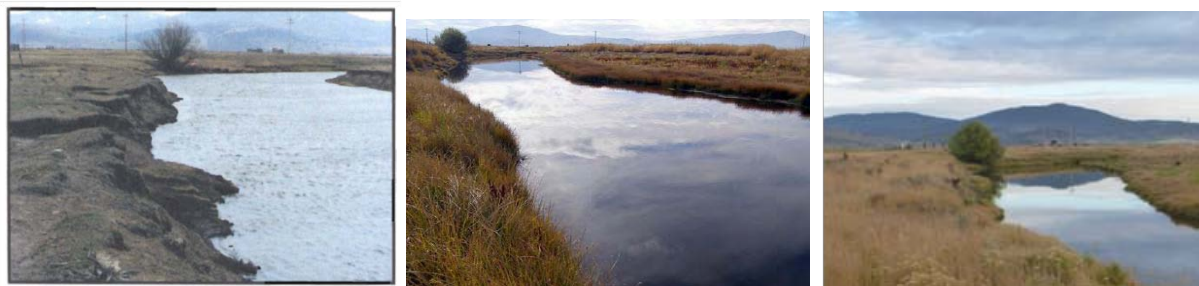
Figure 6.5-6: Conditions in 2001/02 looking at the east bank of the Sycan River adjacent to the ranch house on the project property (left image). Similar location and perspective in 2006 (middle image) and again in 2011(right image) showing regeneration of vegetation in th riparian corridor). Vegetation on the bank helps stabilize the bank and reduces erosion and fine sediment input into the Sprague River Basin.

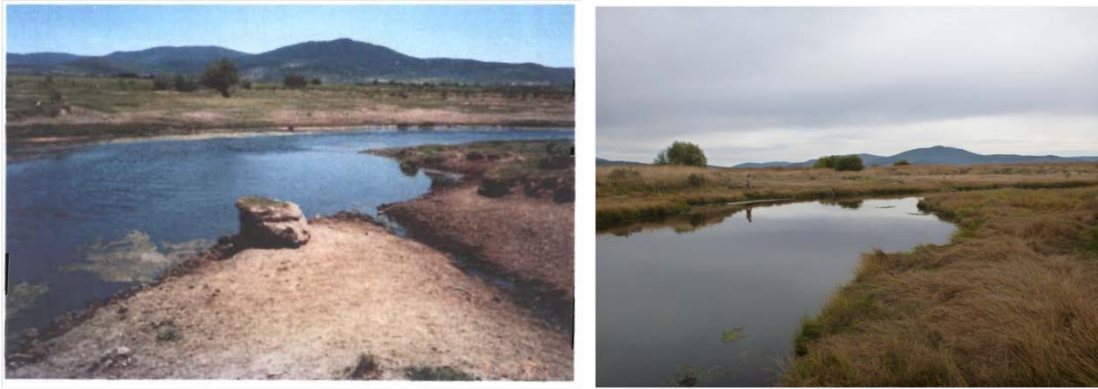
Figure 6.5-7: Conditions in 2001/02 from the middle of the project reach (left image). Similar location and perspective in 2011 showing regeneration of vegetation in the riparian corridor (right image).

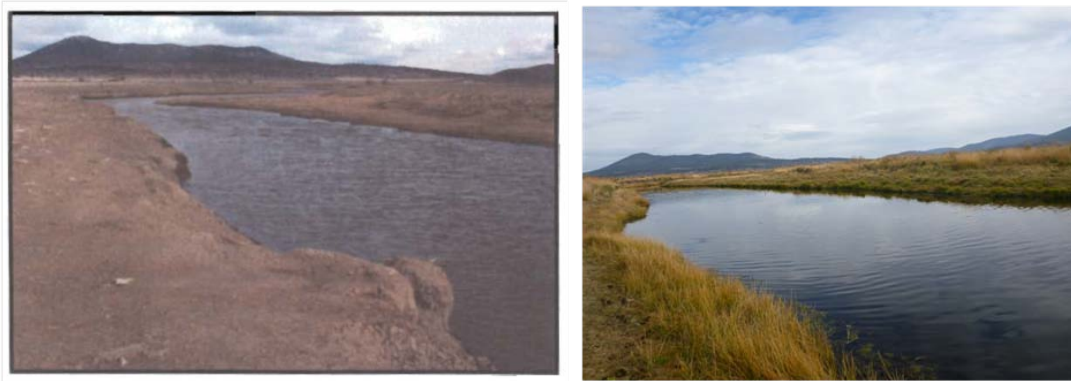
Figure 6.5-8: Conditions in 2001/02 on the west bank of the Sycan River at the downstream extent of the project property (left image). Conditions in 2011 showing regeneration of vegetation in the riparian corridor as a result of the fencing project completed in 2005 (right image).

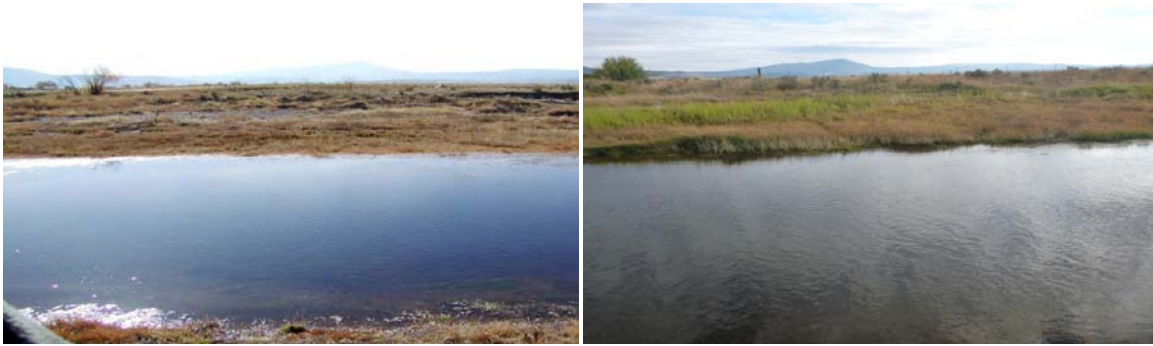
Figure 6.5-9: Conditions in 2001/02 from the Klamath Tribes photo point 2 Angle D (left image). Similar location and perspective in 2011 showing regeneration of vegetation in the riparian corridor (right image).

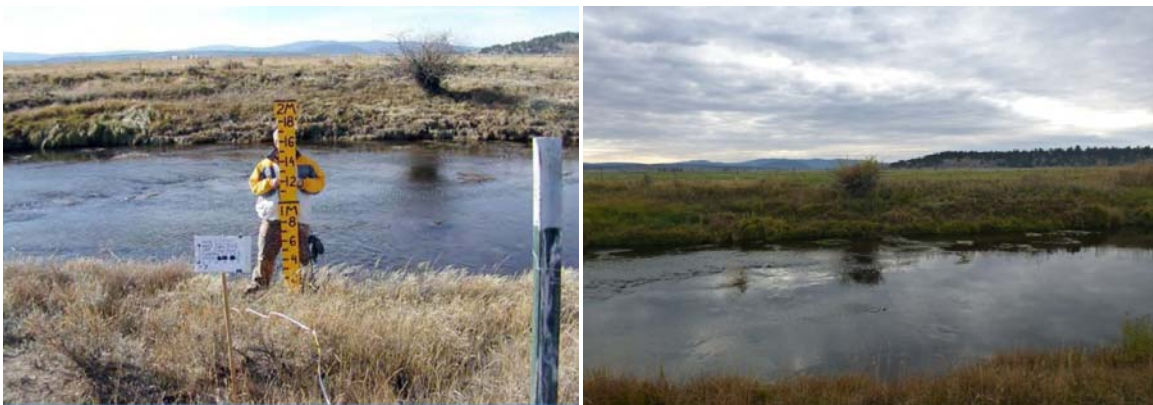
Figure 6.5-10: Conditions in 2001/02 from the Klamath Tribes photo point 7 Angle D (left image). Similar location and perspective in 2011 showing regeneration of vegetation in the riparian corridor (right image).

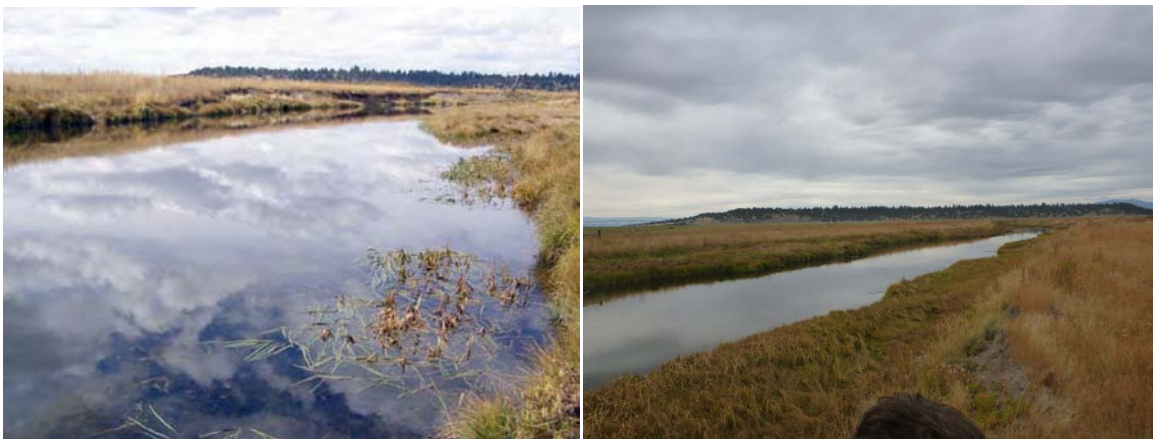
Figure 6.5-11: Conditions in 2001/02 from the Klamath Tribes photo point 12 stream channel (left image). Similar location and perspective in 2011 showing regeneration of vegetation in the riparian corridor (right image).

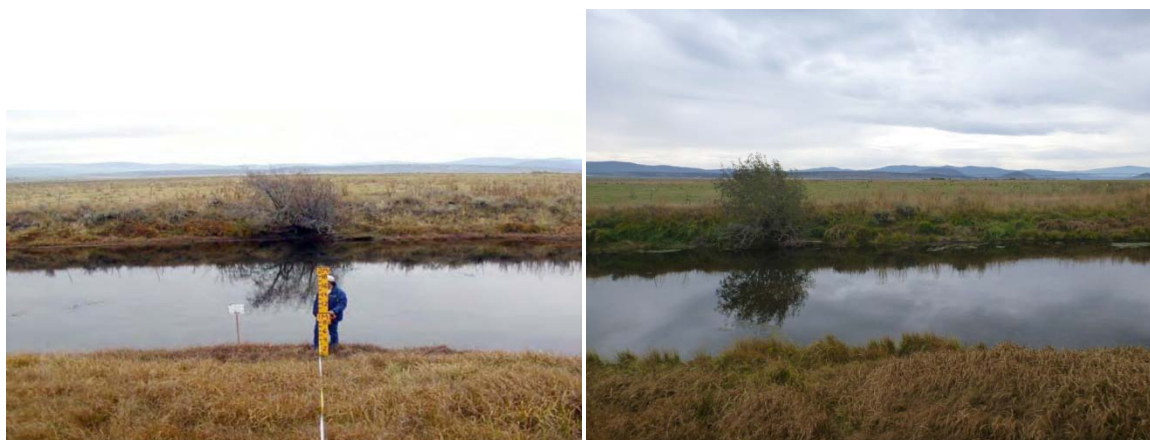
Figure 6.5-12: Conditions in 2001/02 from the Klamath Tribes photo point 13 Angle D (left image). Similar location and perspective in 2011 showing regeneration of vegetation in the riparian corridor (right image).

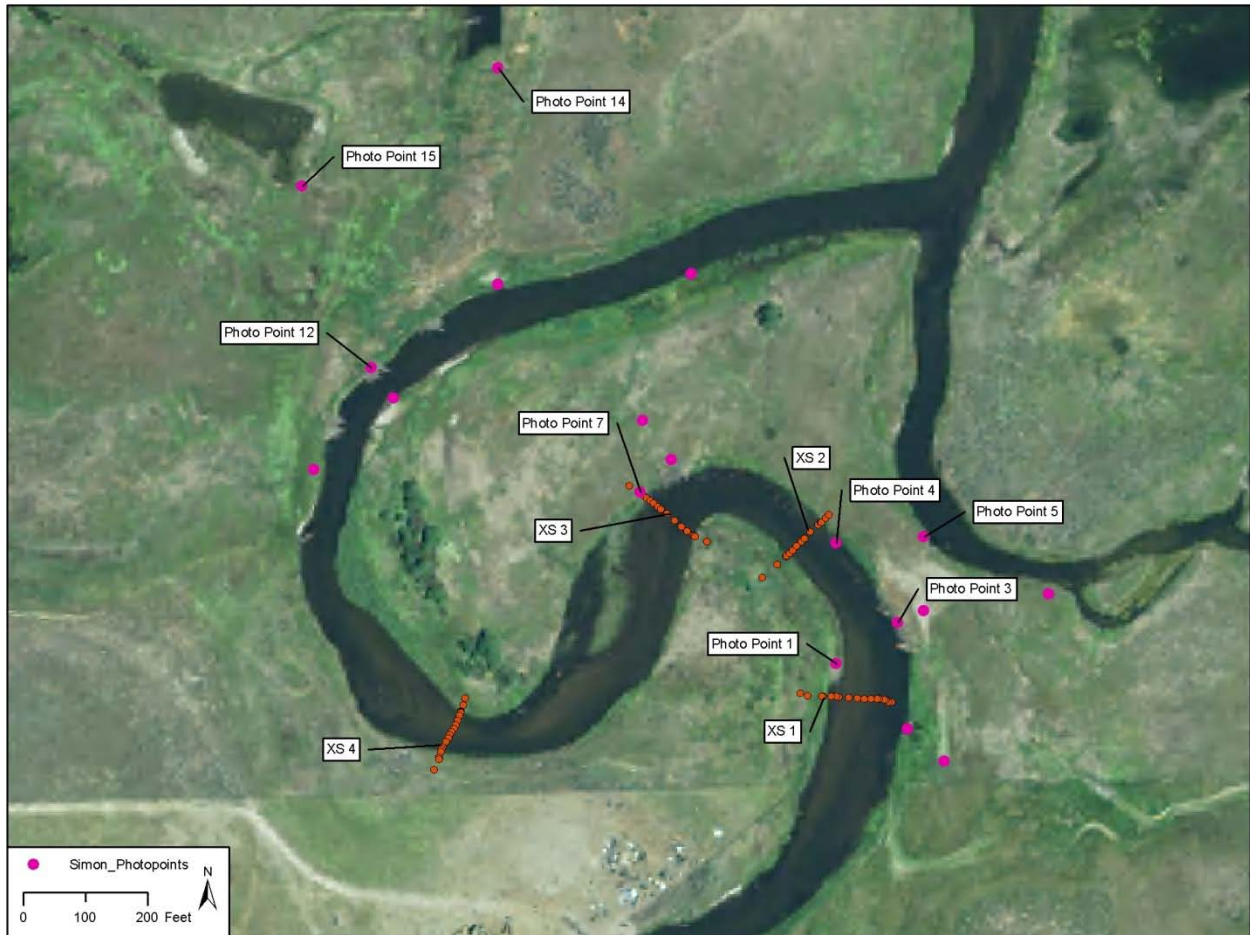
Figure 6.6-3: Location of channel cross sections used to evaluate instream changes between 2005 and 2011, and photo monitoring stations used to evaluate post-project channel stability and revegetation.

We compared pre-project cross-section surveys collected during the design phase with as-built cross-sections and post project cross sections that we collected in 2011 to compare channel geometry over a 6 years spanning project implementation. A longitudinal profile of the channel was performed by RDG during the design phase, but no follow-up longitudinal profile surveys have been performed. No pre- or post-project channel substrate data was available for the project area. Hydrologic data including continuous stage measurements only exists through 1992, when the relevant USGS gage (11497500 Sprague River near Beatty) was discontinued. Data that include pre-project aquatic or riparian habitat surveys, fish monitoring, and water quality monitoring either do not exist, or were not made available for the PPA. The USFWS performed several years of post-project fish and water quality monitoring in the main channel, backwater channels, and reference reaches (for fish monitoring). Finally, photo-monitoring of post-restoration project features provides an indication of channel stability and the success of revegetation efforts (Figure 6.6-3).

To supplement the available post-project monitoring data, we collected additional monitoring data in November 2011 that included assembling historical and current ground and aerial photos, taking photographs at photo-monitoring locations, and resurveying monitoring cross sections (Figure 6.6-3).

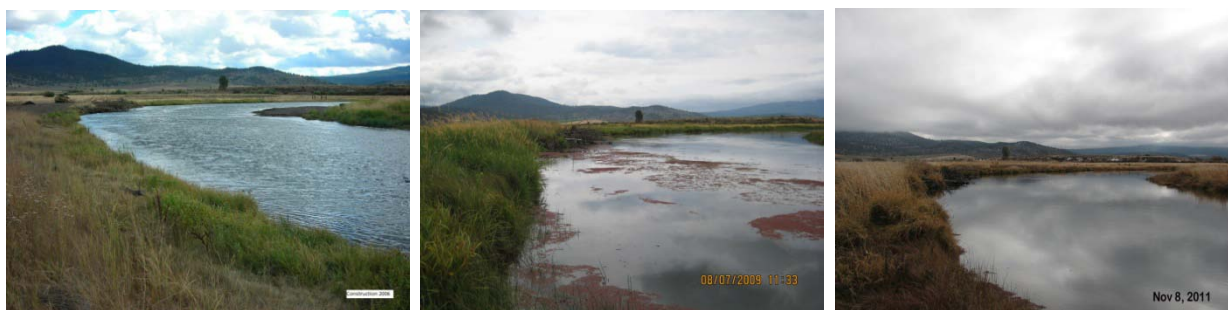
Figure 6.6-8: Photo sequence of Sprague River main channel and riparian vegetation conditions at photo-monitoring station 4, looking upstream from the right bank, 2006 (left photo), August 2009 (middle photo), and Nov 2011 (right photo).

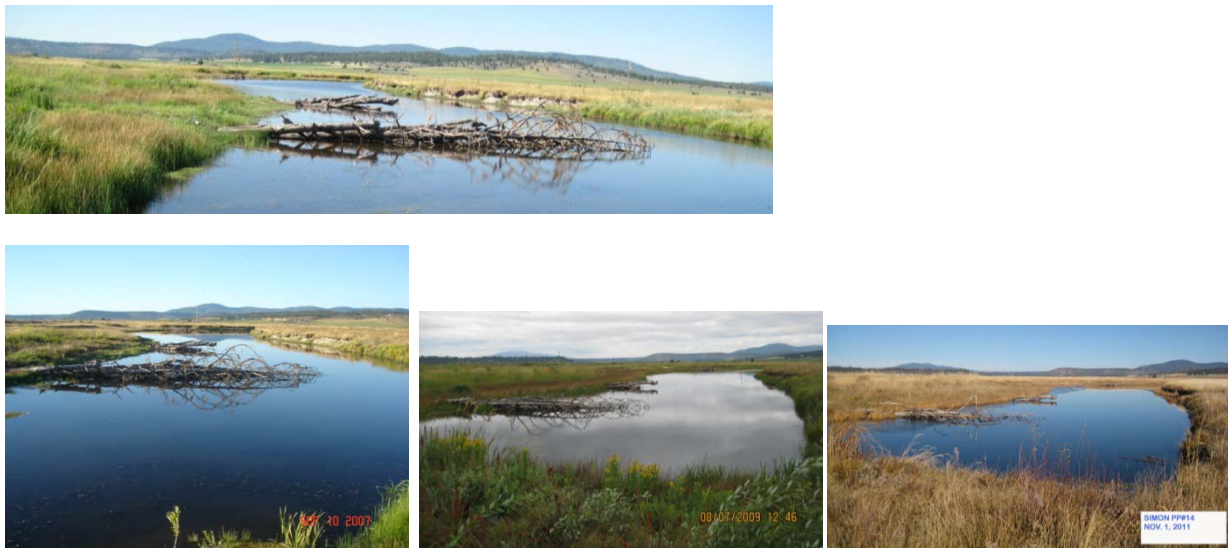
Figure 6.6-10: Photo sequence of the Backwater 2 conditions at photo-monitoring station 14, looking north from the channel plug, 2005 (top), Sept 2007 (bottom left), August 2009 (bottom middle), and Nov 2011 (bottom right).

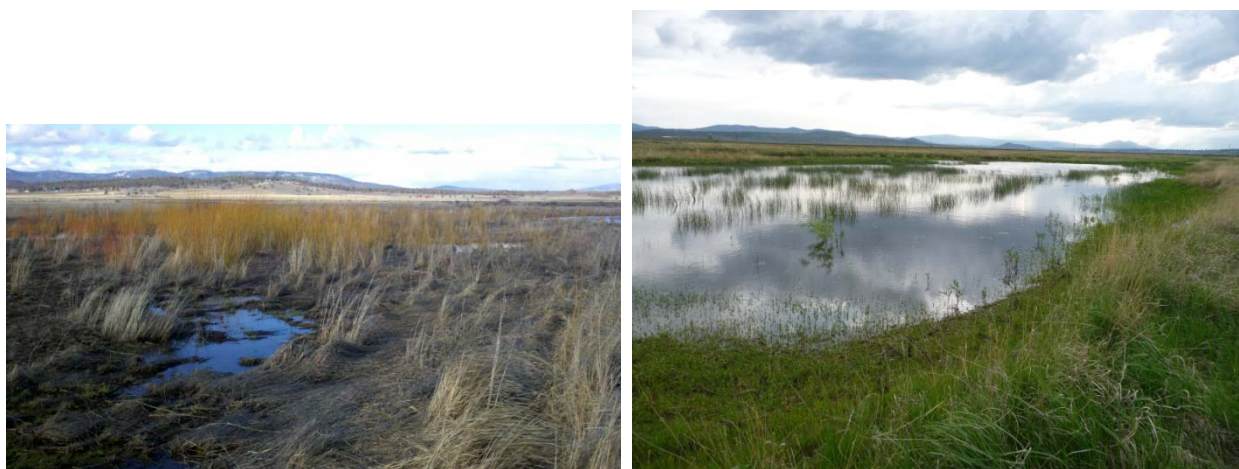
Figure 6.6-11: Recent willow growth in and around Plug 2 (photos from Troy Bradt, RDG, 2012).

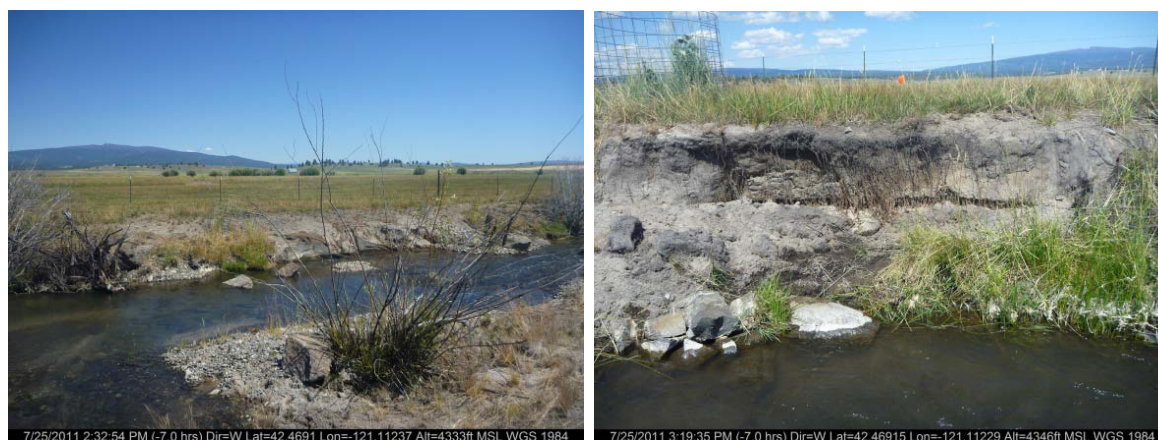
Figure 6.7-7: Conditions in July, 2011, showing bank erosion (left image) and high mortality/low vigor of willow and alders planted in the project reach (right image).

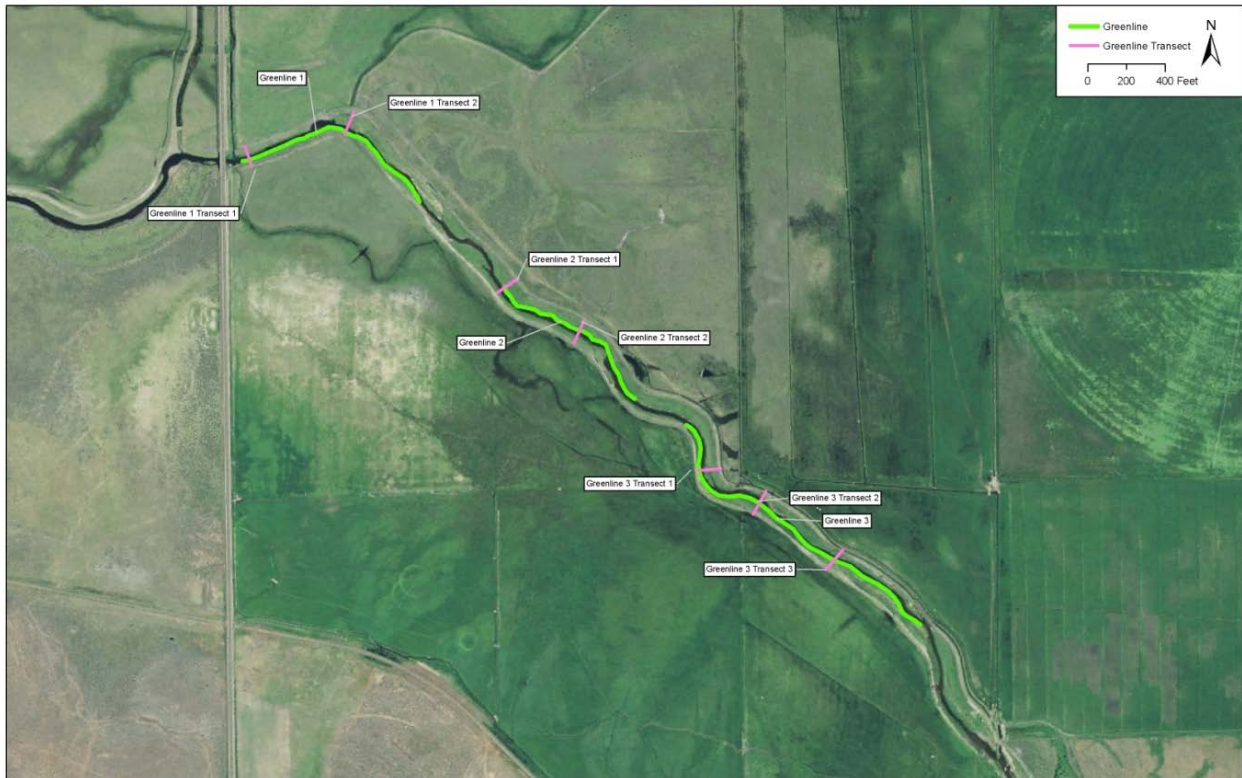
Figure 6.8-2: Location of greenline surveys and transects in the downstream most mile of the project.

To evaluate the performance of this project with respect to stated riparian vegetation success criteria, we assessed regeneration and native grass and forb composition with a greenline survey alternating

between the right and left bank for approximately one mile near the downstream extent of the project site (Figure 6.8-2). The effects of cattle exclusion are clearly shown in the two photographs taken from the Camp Six Road Bridge in Figure 6.8-3. Cattle exclusion over the past two years has allowed grasses to regenerate and has increased the height of grasses along the channel; however, the composition of grasses is predominately non-native species. Without management or planting, non-native species out compete the native plant species.
