Evaluating Stream Restoration Projects in the Sprague River Basin

Prepared for:

Klamath Watershed Partnership, in conjunction with the Klamath Tribes, the U.S. Fish and Wildlife Service, the Klamath Basin Rangeland Trust, Sustainable Northwest, and The Nature Conservancy

NewFields River Basin Services & Dr. G. M. Kondolf

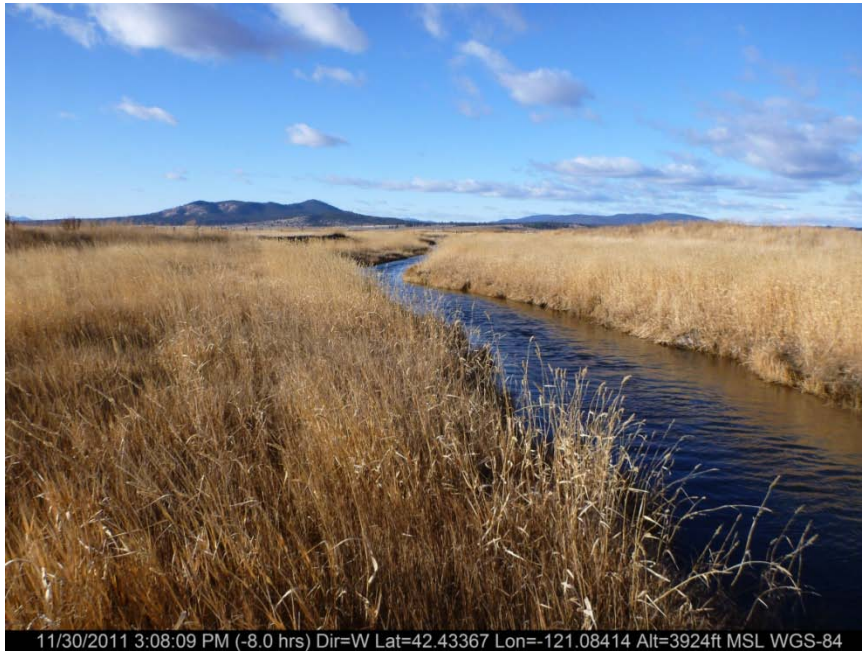
Figure 6.8-4: Photo of the riparian zone in the project area showing the dominance of reed canary grass along the greenline in this reach of the river. Reed canary grass has vegetated the channel banks, which shows a reduction of the impact on the channel from cattle grazing, but has out competed native species.

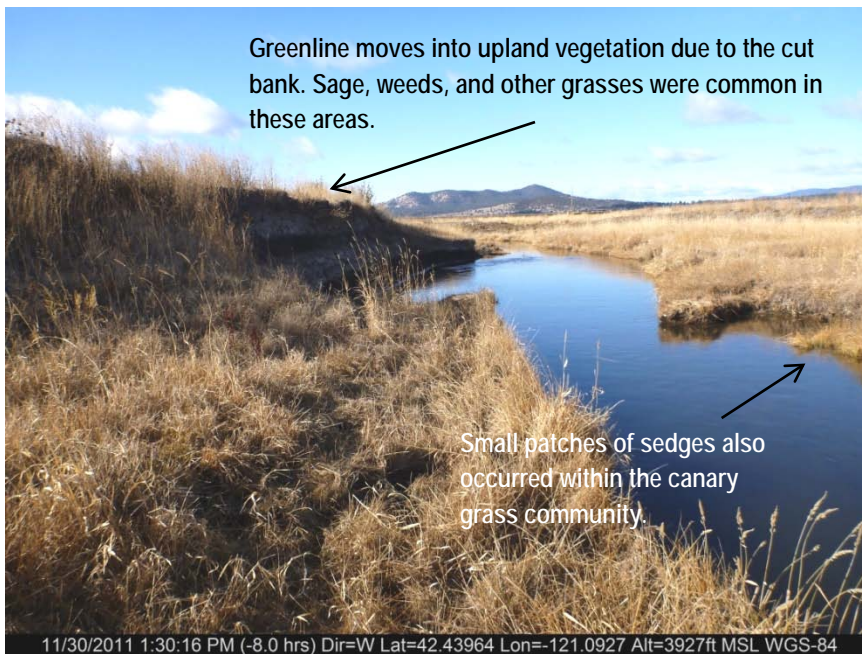
Figure 6.8-5: Photo showing typical vegetation, still dominated by reed canary grass on the lower bench, but with other components present on the greenline due to erosion within the leveed channel.

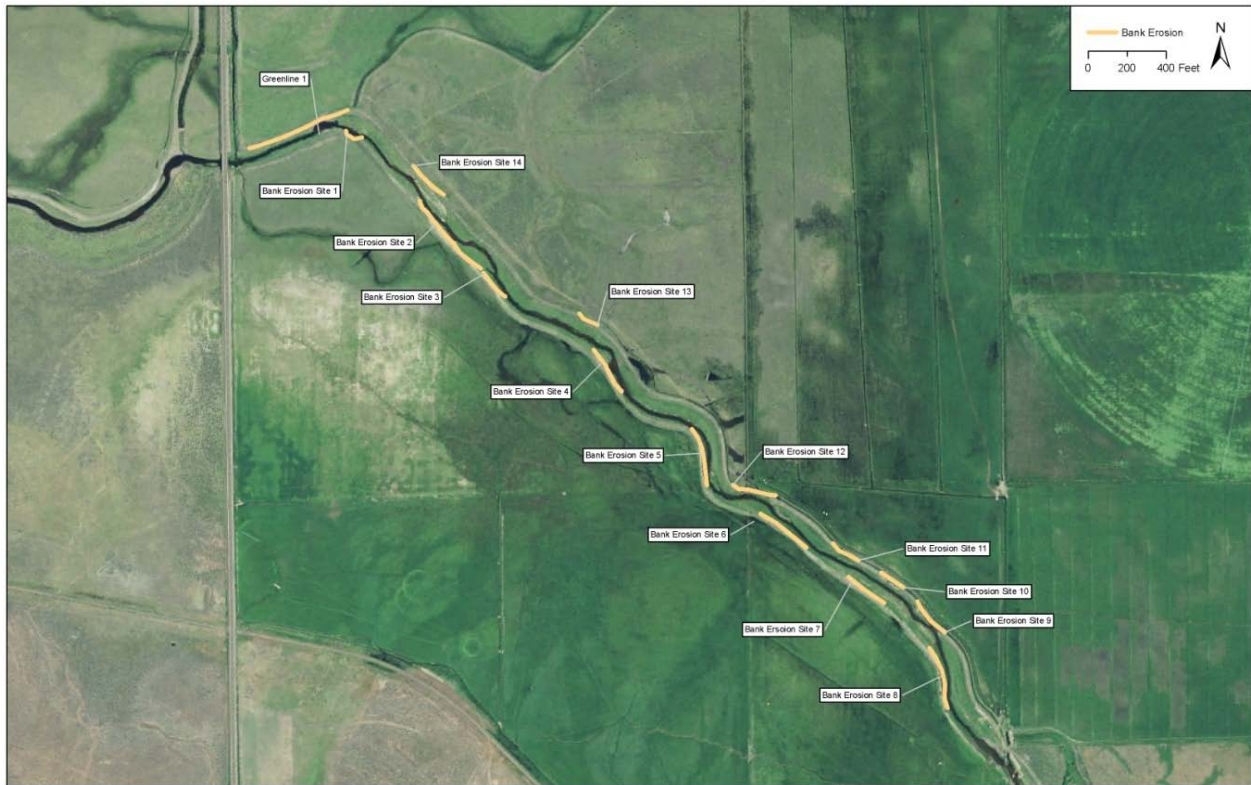
Figure 6.8-6: Bank erosion sites identified during post project appraisal.

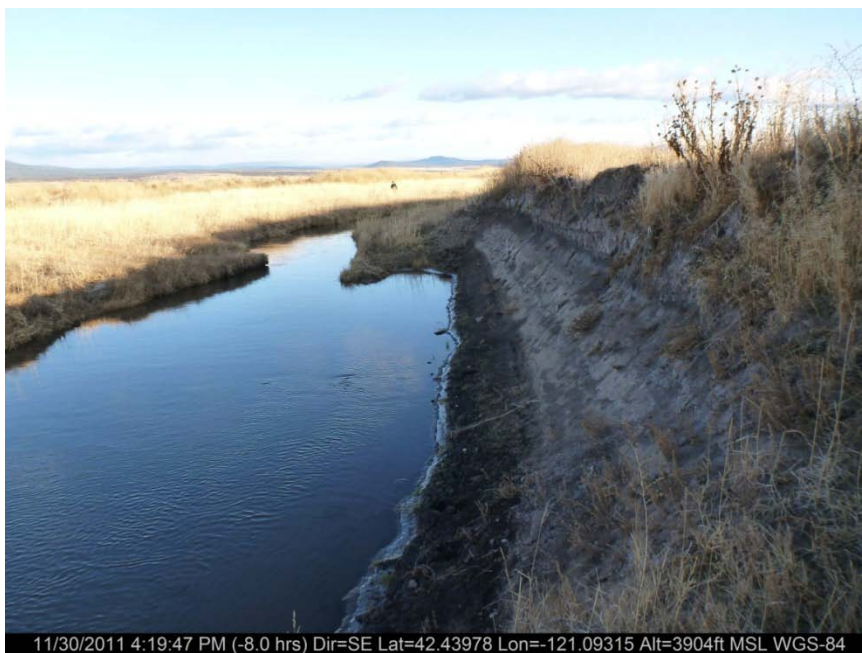
Figure 6.8-7: Bank erosion on an outside bend of the channel where eroded material has been transported downstream

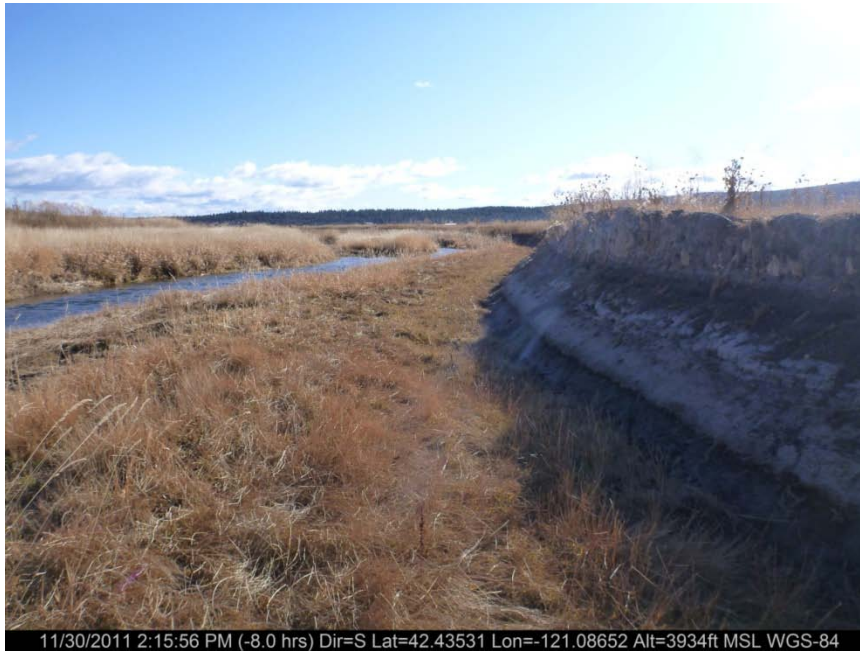
Figure 6.8-8: Bank erosion on the inside bend of the channel where eroded material has formed a lower surface that has been colonized by grass.

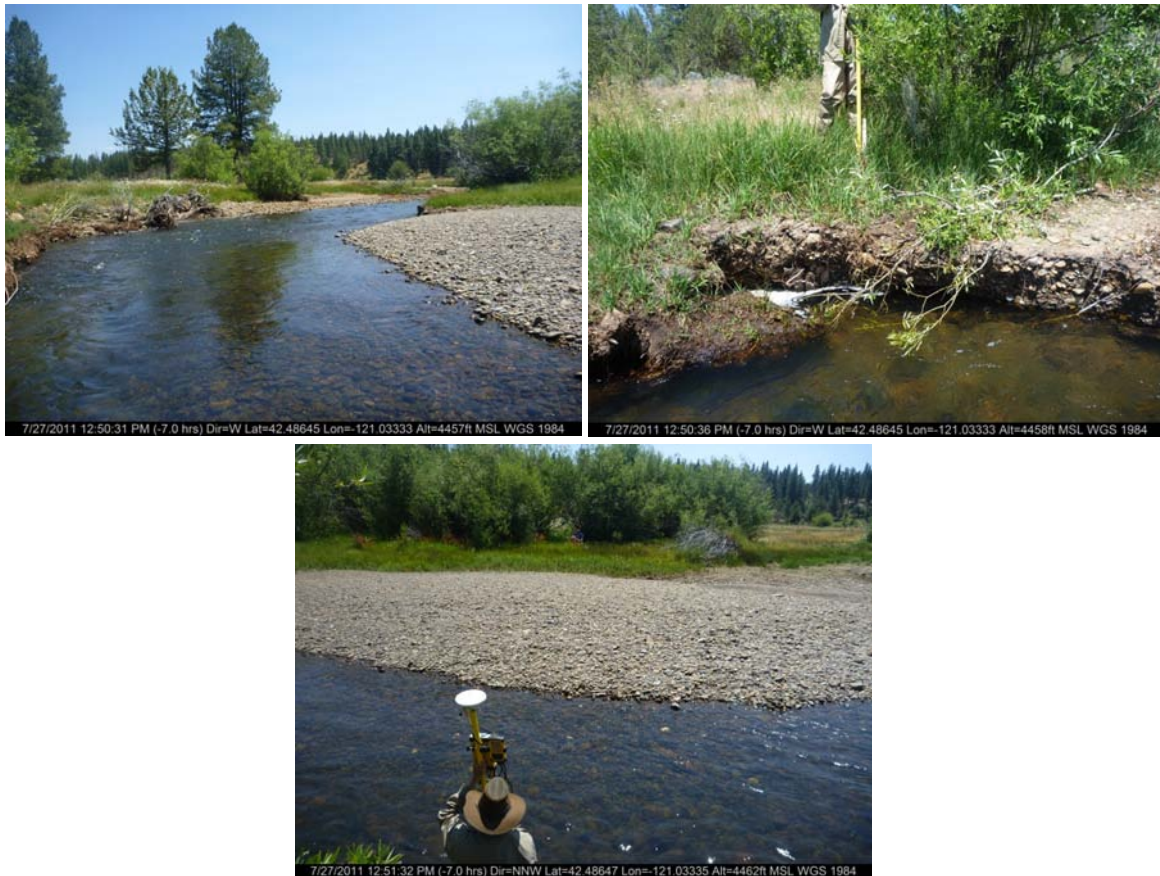
Figure 6.9-8 Looking upstream (upper left photo) showing bank erosion on the outside bank (upper right photo) and formation of a point bar on the inside of the channel (lower center photo). Photos taken at cross section H, illustrating active channel bank migration.

We established ground photographic monitoring locations at each cross section end pin and the thalweg (deepest part) of the channel. We took digital photographs looking upstream, across the channel, and downstream from each cross section end pin. From the channel thalweg, we took digital photographs looking upstream and downstream and towards both banks. We collected GPS waypoints at each digital photograph and used software to write the GPS coordinates, date, and time on each photograph. We exported the coordinates and the file name of each photograph to a GIS shapefile and incorporated the shapefile into the SPPAMS for the project. Digital photographs are included the data DVD with the project. Future monitoring should include revisiting the photo points we established. Figure 6.9-8 shows

cross section H, which is likely to change over time as the point bar on the inside of the bend continues to build from material eroded from the outside bank of the bend.

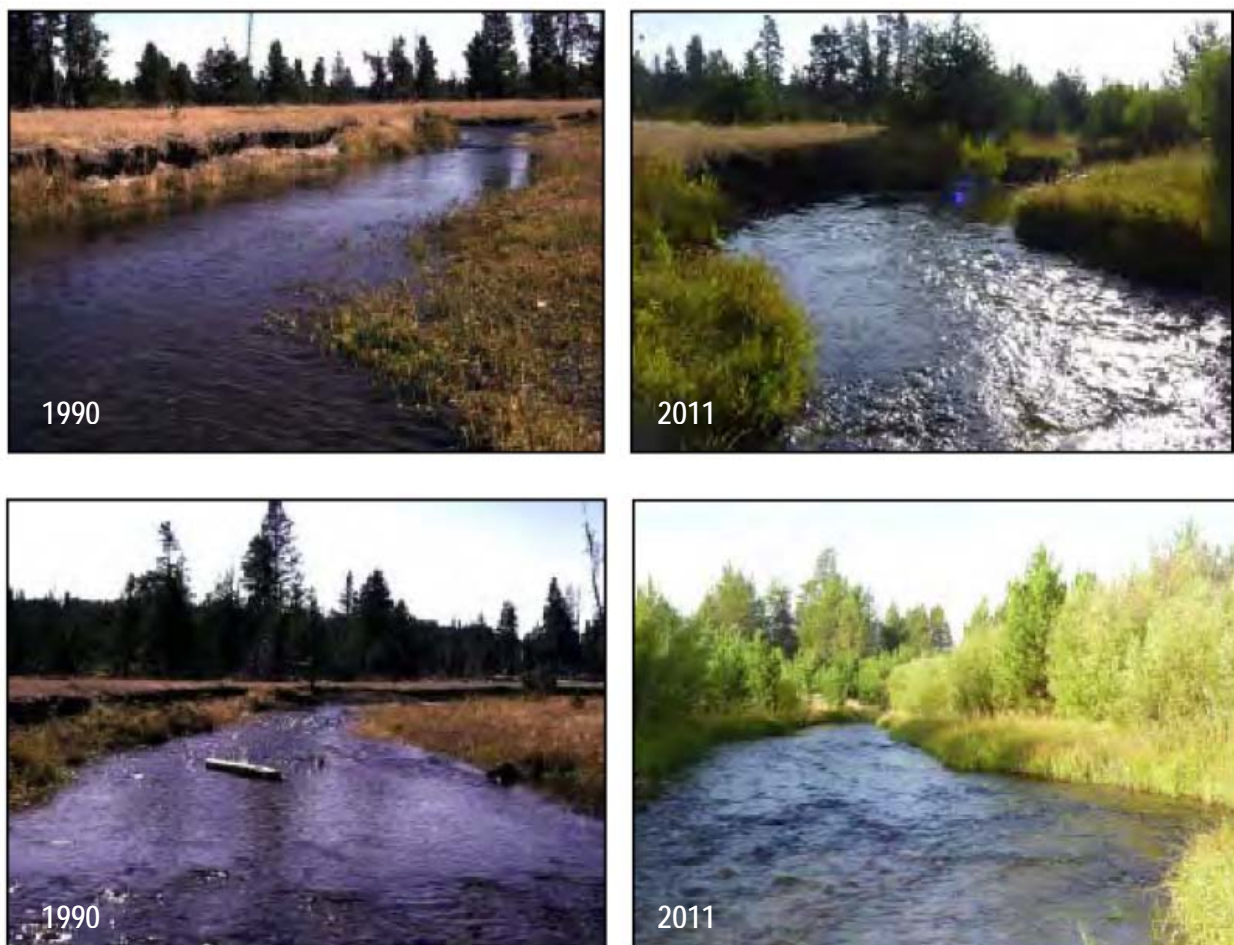
Figure 6.10-7: Photo-monitoring series at station R1S1, near the upstream extent of the project site, showing riparian revegetation from 1990 to 2011 looking downstream (top) and upstream (bottom) from the channel cross-section (Source: Doehring et al 2011).

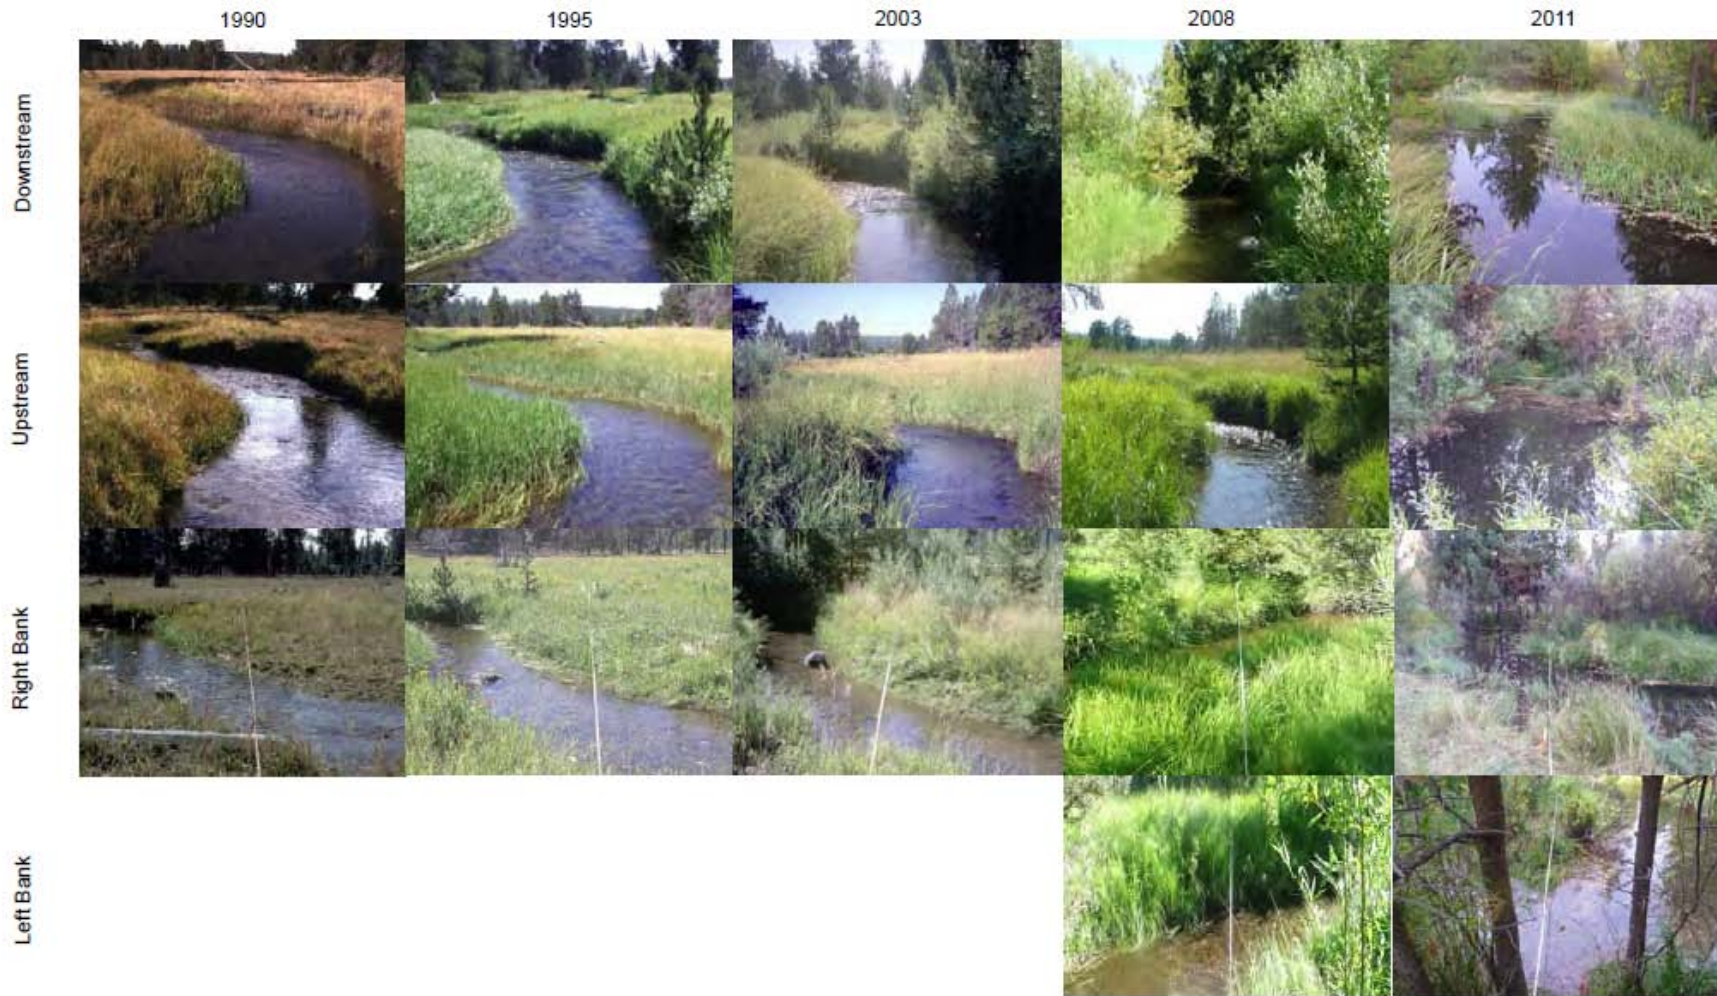
Figure 6.10-8: Photo-monitoring series at station R4S3, near the downstream extent of the project site, showing riparian revegetation from 1990 to 2011 along several different aspects of the channel cross-section (Source: Doehring et al 2011).

These photo-monitoring series show the following trends:

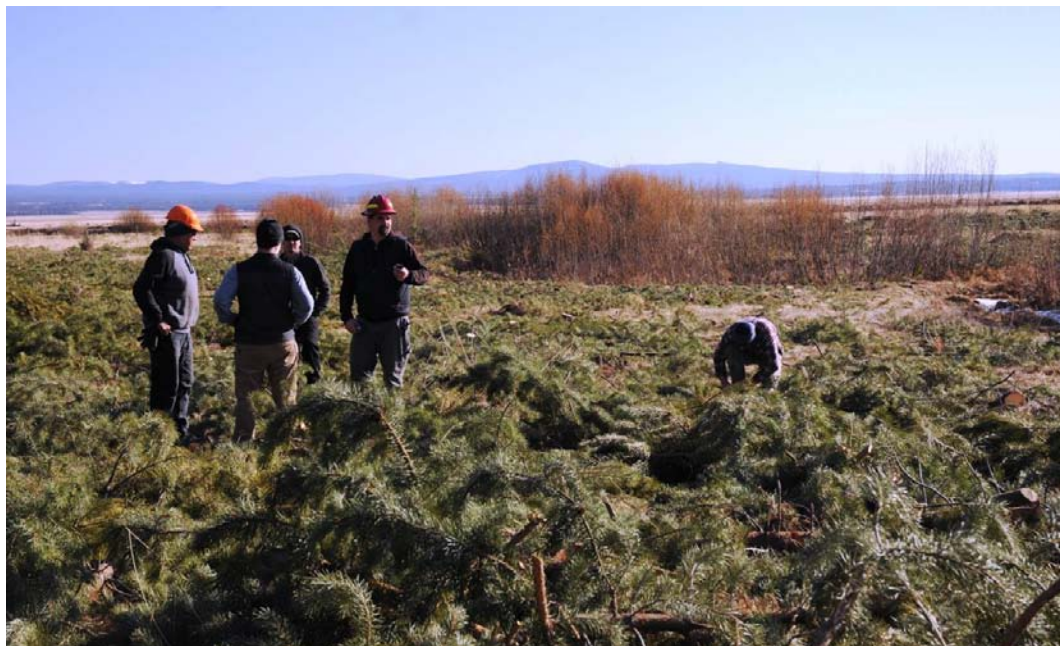
Figure 6.10-9: Picture illustrating lodgepole harvest that TNC completed in 2011. This picture is of Coyote Creek, but similar conditions exist at Long Creek (Craig Bienz 2012).

This period also showed an increase in conifer growth, specifically Lodgepole pine (*Pinus contorta*), in the riparian areas. Lodgepole pine trees tend to establish quickly in valley bottom areas that have been disturbed. The presence of these species is not necessarily desirable, since they consume large amounts of water leading to drier conditions in the riparian zone, and potentially causing a positive feedback of additional lodgepole establishment. This could ultimately direct the ecosystem towards a drier, more pine-dominated trajectory than the historical conditions along Long Creek (Doehring et al 2011). To address this issue, TNC initiated a lodgepole harvest along the valley bottom areas within the Long Creek project site, which was completed in December 2012 (Figure 6.10-9; pers. comm. with C. Bienz, The Nature Conservancy, 2012). Prescribed fire will be applied in the fall of 2013 to further restore riparian forest structure through the Long Creek corridor.
