Large-scale dam removal on the Elwha River, Washington, USA: Source-to-sink sediment budget and synthesis

Jonathan A. Warrick^{a,*}, Jennifer A. Bountry^b, Amy E. East^a, Christopher S. Magirl^c, Timothy J. Randle^b,
Guy Gelfenbaum^a, Andrew C. Ritchie^d, George R. Pess^e, Vivian Leung^f, Jeffrey J. Duda^g

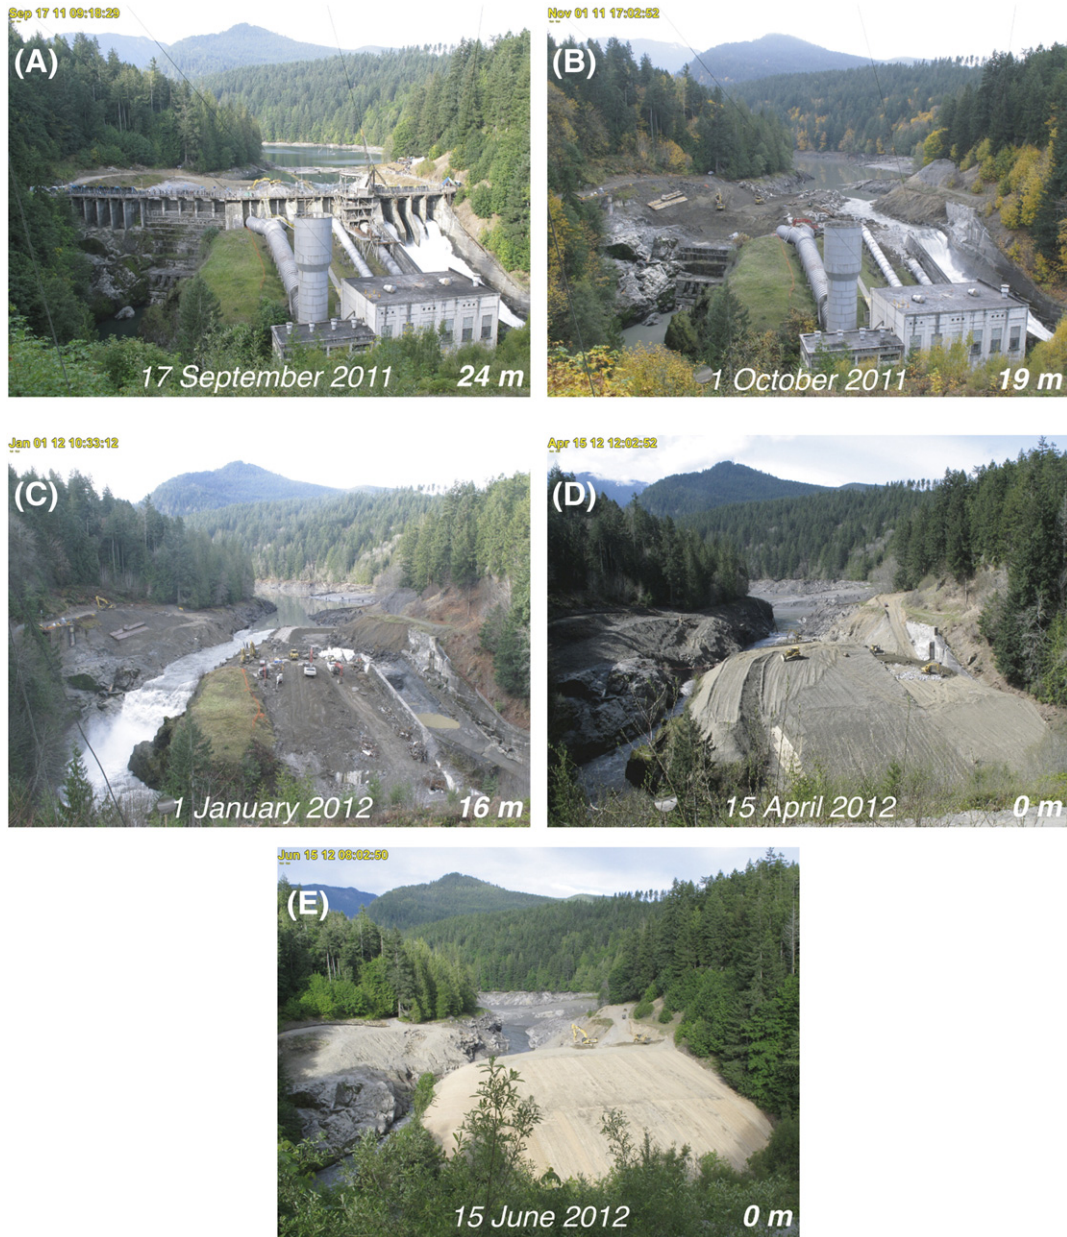
Fig. 2. Decommissioning of Elwha Dam as shown by photos from National Park Service time-lapse cameras. Dates and remaining heights of the water surface above the original channel bed are shown in each photo. (A) The initiation of dam removal in mid-September 2011. Removal of the dam involved successive excavation of the spillway (B; right side of photo) and the dam structure (C; left side of photo) and multiple managed shifts using earthen cofferdams to alter the river course through these waterways. (D) The Elwha River in the spring of 2012 following the final managed river shift into the excavated canyon. (E) Final graded hillside of the Elwha Dam site following dam removal. Photos provided by Erdman Video Systems in collaboration with the National Park Service.

Elwha Dam was removed by a sequential series of excavations and channel switching through two alignments, the spillway and the original canyon, owing to the geometry and amount of rock fill upstream of this structure (Fig. 2A–C). The fill material near the dam included rocks, wood *mattresses*, hydraulically placed sediment, and gunnite placed to help rebuild the concrete dam after the original structure failed in 1912. During removal, switching between the two channels was orchestrated by use of temporary earthen cofferdams, and the final channel change back into the original canyon was conducted on 16 March 2012, six months after removal began (Fig. 2D). Once the river was diverted into the natural canyon alignment for the last time, the dam and spillway sites were graded and revegetated (Fig. 2D, E). Excavation of the dam fill material from the river channel continued in late March and April 2012, and these activities resulted in a lowering of the river channel elevation and full progradation of the reservoir's delta (Fig. 4) to the dam site in late April 2012.

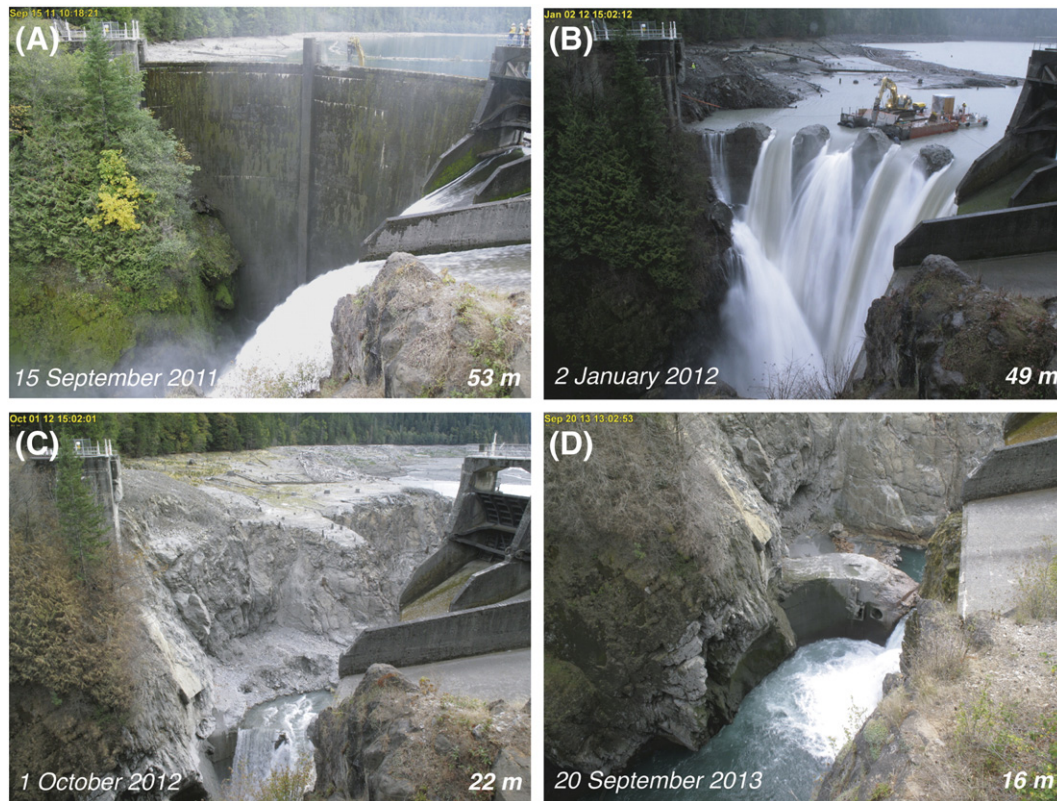
Fig. 3. Decommissioning of Glines Canyon Dam as shown by photos from National Park Service time-lapse cameras. Dates and heights of the water surface above the original channel bed are shown in each photo. (A) The initiation of dam removal in mid-September 2011. An excavator floating on a barge and equipped with a hydraulic hammer can be seen near the center of the dam. (B) After 3.5 months the upper portion of the dam had been removed, and river discharge no longer could be passed through the spillways in the foreground. (C) After 1 year the reservoir sediment delta had prograded to within 100 m of the dam. (D) Although the reservoir delta prograded to the dam during high flows of October 2012 and sediment could spill directly into the channel below, the river had low turbidity during the summer low flow season of 2013. Photos provided by Erdman Video Systems in collaboration with the National Park Service.

During the removal of Glines Canyon Dam, water was passed through the dam's gated spillways while a hydraulic hammer—mounted on an excavator that was floating on a barge—was used to chip away at the dam's concrete structure (Fig. 3A). As the dam was lowered below the spillways, water passed directly over the remaining crest of the dam, which was still being removed by hydraulic hammer (Fig. 3B). The lowering of Lake Mills water levels resulted in delta progradation toward Glines Canyon Dam (Fig. 4A). Beginning in July

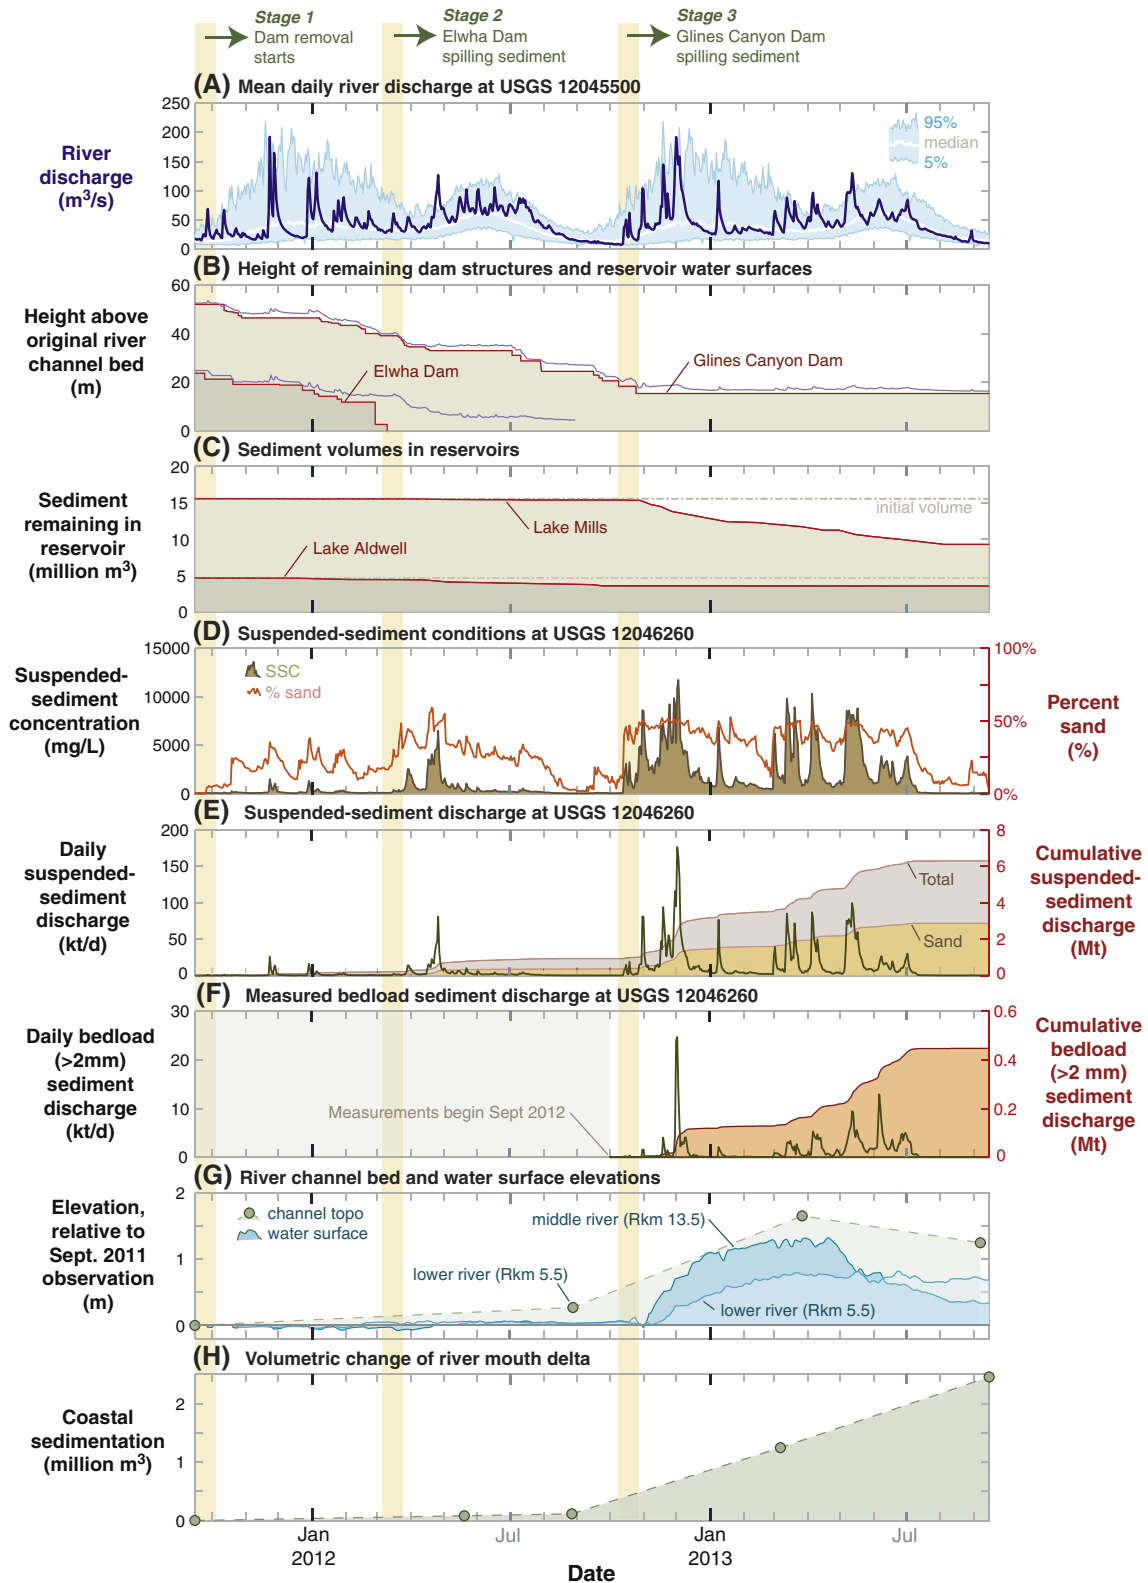
Fig. 5. Time series of reservoir, river, and coastal measurements showing the geomorphic effects of dam removal on the Elwha River. Three primary intervals of time, or stages, that are highlighted in the text are shown with vertical bars. (A) Elwha River discharge during the study (dark line) over the 99 years of daily records. The 5% and 95% percentiles of discharge on each day of the year are by the extents of the light shading. (B–C) Reservoir heights and sediment volumes (after Randle et al., 2015-in this issue). (D–F) River sediment discharge measurements (after Magirl et al., 2015-in this volume). (G) River vertical geomorphic change from water level and channel cross-section topographic measurements (after East et al. (2015-in this issue)). (H) Coastal volumetric change of the river mouth delta (after Gelfenbaum et al., 2015-in this issue).

Downstream sediment flux increased markedly after the Elwha River was placed into its natural canyon alignment past the former Elwha Dam site on 16 March 2012 and Lake Aldwell, having been drained of water, no longer functioned as a sediment trap. These physical conditions, coupled with spring high flows, resulted in suspended-sediment concentrations in the downstream river that regularly exceeded 1000 mg/L and suspended-sand fractions that approached 50% during most of the spring of 2012 (Fig. 5D). The river discharged ~410,000 t of suspended sediment and ~70,000 t of bedload during the 22 days between 13 April and 5 May, and roughly half of this suspended-sediment discharge was sand (Fig. 5D, E). These measurements of total sediment flux in the river (~480,000 t) were roughly equivalent to the total volume of sediment exported from the reservoirs during the same 22 days; Lake Aldwell sediment storage decreased by ~430,000 m³ and Lake Mills sediment storage decreased by ~50,000 m³ (Fig. 5C). The smaller amount of export from Lake Mills was not from lower erosion rates of this reservoir's delta, but rather from continued deposition of eroded sediment within the remaining boundaries of the reservoir. That is, the Lake Mills delta continued to incise and prograde during the spring and summer of 2012 (Figs. 3 and 4A; Randle et al., 2015-in this issue). In summer when discharge waned, suspended-sediment concentrations and sand fractions decreased, such that from mid-August to mid-September of 2012, suspended-sediment concentrations were only 50–100 mg/L with <5% sand (Fig. 5D).

Approximately 930,000 t of suspended-sediment was discharged past the downstream-most USGS station during the first year of dam removal, over two-thirds of which occurred during stage 2 (Table 4; Fig. 5E). An additional 170,000 t of bedload discharge from former Lake Aldwell was estimated for this time interval, which combined to 1.1 million t of total sediment discharge, or about 3 times the mean annual supply from the upper watershed (Table 4; Magirl et al., 2015-in this volume). During the first year of dam removal ~1.1 million t of sediment was exported from Lake Aldwell and ~230,000 t was exported from Lake Mills (Table 4; Fig. 5C).

in the thalweg, and more where pools filled (Fig. 5G; East et al., 2015-in this issue). These results showed that river sedimentation was generally limited to pools between riffles and slow velocity areas along

channel margins (East et al., 2015-in this issue) but had not yet occurred on the riffle crests that exert hydraulic control on water-stage elevations. In total ~80,000 t of sediment, or roughly 7% of the measured river sediment flux, was deposited during the first year of dam removal in the mainstem and floodplain channels of the Elwha River's lower reach (i.e., the reach between Elwha Dam and the coast), most of which occurred during stage 2 (Table 4). The 2012 coastal surveys revealed that ~240,000 t of sediment was deposited immediately offshore of the river mouth, which was roughly 22% of the total measured sediment flux in the river (Fig. 5H; Table 4; Gelfenbaum et al., 2015-in this issue).

Although sediment supply from Lake Mills continued through much of this second year (stage 3), the middle reach mainstem channel partially incised through the recently deposited sediment during the spring and summer of 2013 (Fig. 5G). Widespread incision was not observed in the river's lower reach, however (Fig. 5G). Incision within the fluvial deposits of the middle reach was coincident with a slight coarsening of the channel sediments, whereas the deposits in the lower reach—where incision was observed only locally—continued to fine during the spring and summer of 2013 (East et al., 2015-in this issue).

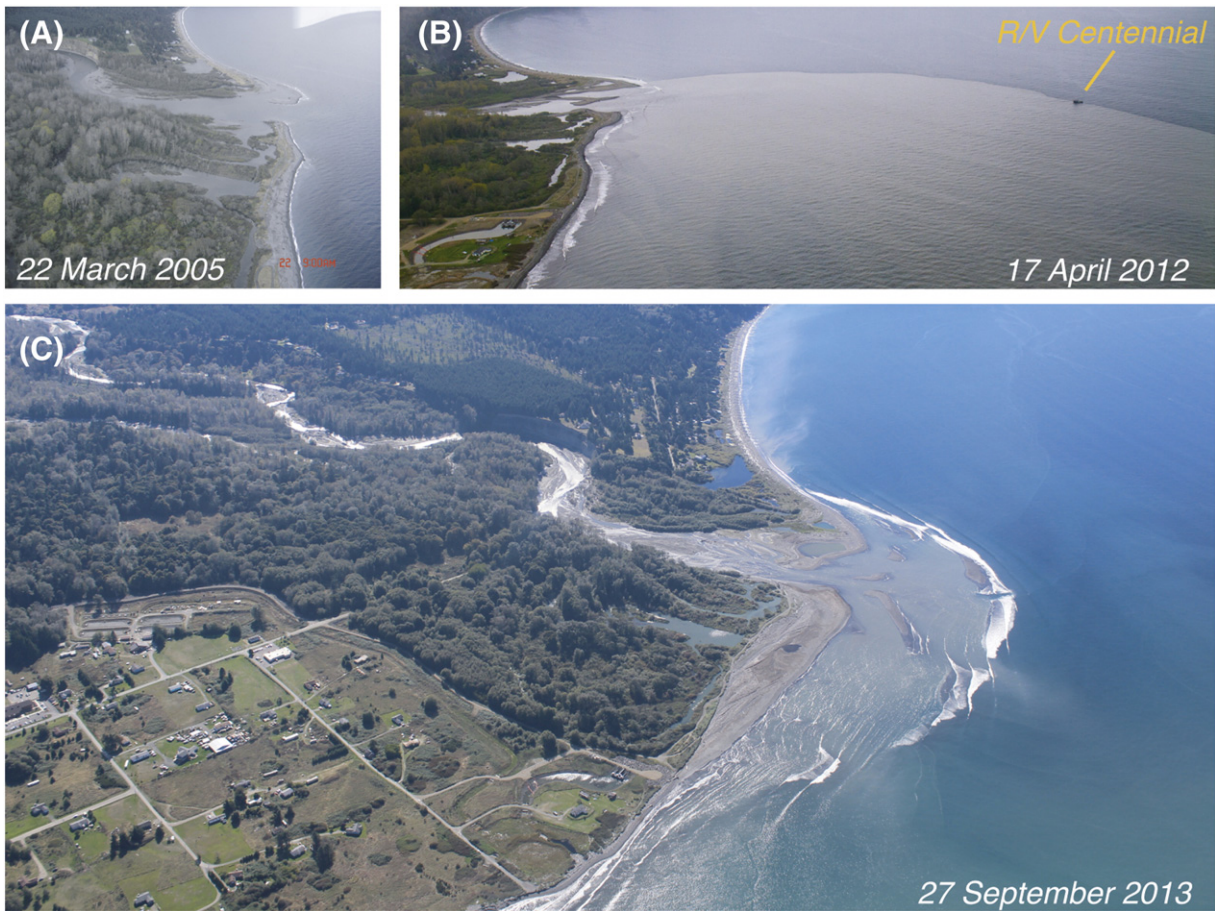
Fig. 7. Oblique aerial photos of the Elwha River mouth before and during dam removal. Photos show (A) the river mouth wetlands before dam removal, (B) the turbid buoyant coastal plume that occurred during much of the dam removal project, and (C) the expansion of the river mouth delta by ~ 2.4 million m^3 of sediment deposition. The R/V Centennial shown in (B) is 18 m in length. Photos provided by Ian Miller of Washington Sea Grant, Jonathan Felis of USGS, and Neal and Linda Chism of LightHawk.

The geomorphic effects of these renewed sediment supplies during stage 1 were minor. For example, Draut and Ritchie (2013) reported relatively thin (<20 cm) deposits of mud and sand along the banks of the Elwha River downstream of both dams (i.e., the 'lower reach' of the river) during the spring of 2012 (Fig. 6B). During this time, relative river water stages did not increase (Fig. 5G), indicating that the thin channel margin deposits exhibited no hydraulic control on the river flow (East et al., 2015-in this issue). The primary coastal effect observed during stage 1 was the several-kilometer-scale turbid buoyant plume that commonly extended from the river mouth into the Strait of Juan de Fuca (Fig. 7B; Gelfenbaum et al., 2015-in this issue).

At the coast, a massive expansion of the river mouth delta was observed during the second year of dam removal, such that the river-mouth wave-breaking zone moved over 200 m in the offshore direction (Fig. 7C). Detailed coastal surveys revealed that this expansion was associated with ~2.2 million m³ (~3.3 million t) of sediment deposited during the second year of dam removal (Fig. 5H; Gelfenbaum et al., 2015-in this issue). Although most of this sediment was sand and gravel, a broad patch of mud was found to cover the seafloor 0–2 km west of the river mouth, where coastal hydrodynamics were more quiescent and less conducive to transport (Gelfenbaum et al., 2015-in this issue). A secondary region of sand deposition was observed ~1.5 km east of the river mouth in 0–5 m water depths, and this 1–2 m thick deposit resulted from eastward transport of sediment deposited initially offshore of the river mouth (Gelfenbaum et al., 2015-in this issue). In contrast to the massive expansion of the river mouth delta, erosion was still measured along 1 km of the deltaic shoreline to the east and directly downdrift of the river mouth during the second year of dam removal (stage 3). This indicates that the massive supply of sediment did not immediately reverse the sediment deficit for this littoral cell (Gelfenbaum et al., 2015-in this issue).

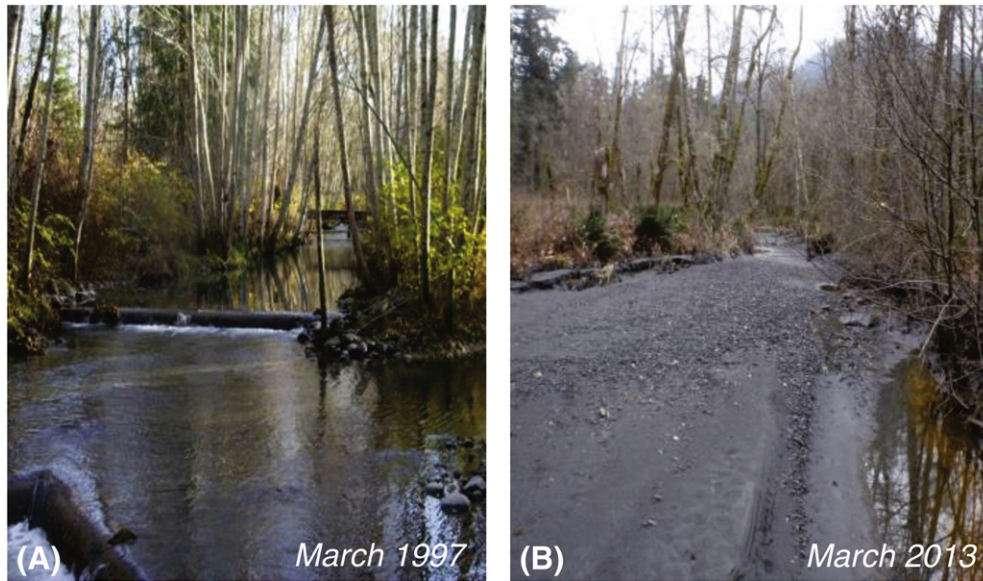
Fig. 9. An example of the sedimentation and geomorphic change that occurred within the Elwha River floodplain channels during dam removal. An average of 0.50 m (± 0.38 m) of deposition occurred in the eight floodplain channels surveyed (East et al., 2015-in this issue). Photos taken looking upstream at the Boston Charley floodplain channel, which enters the Elwha River at Rkm 0.6. Photos provided by Mike McHenry, Lower Elwha Klallam Tribe.

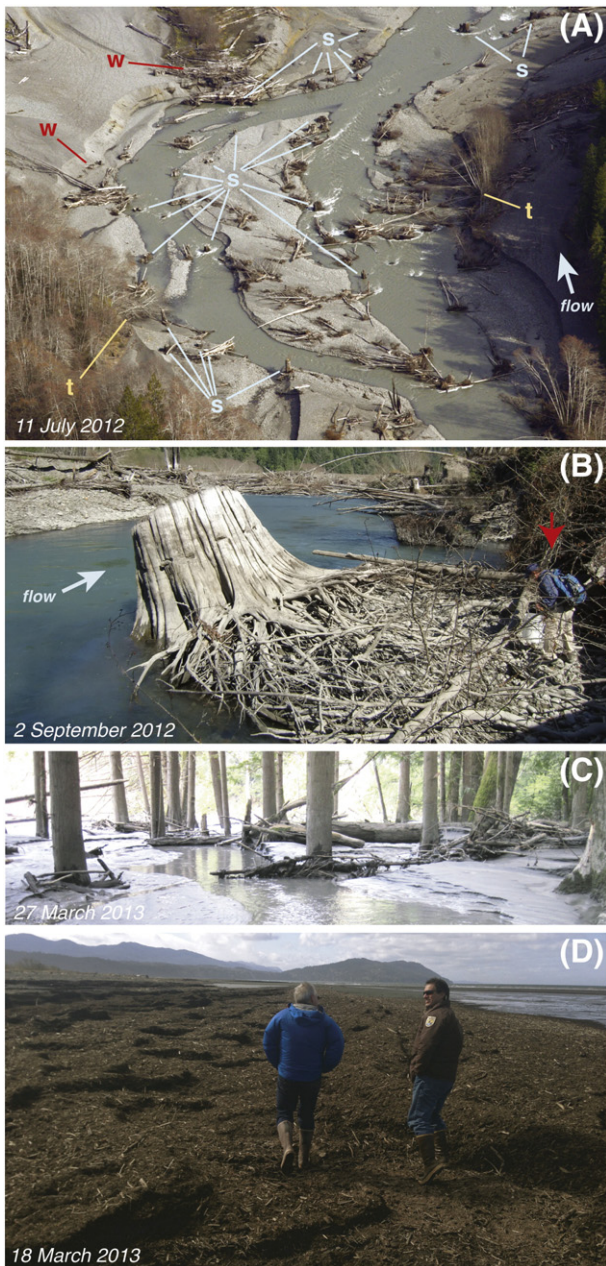
Fig. 14. Photographs of woody debris exposed and transported during dam removals on the Elwha River system. (A) Oblique aerial photo of the Lake Aldwell delta following full removal of Elwha Dam. Several sources of woody debris can be identified in the photo, including: stumps (s) of trees that were cut before dam construction and were buried in delta sediment; riparian trees (t) delivered to the river from bank erosion; and woody debris (w) formerly deposited on and within in the reservoir sediment. (B) A stump exhumed from the Lake Aldwell delta sediment by river erosion. A person for scale is highlighted with an arrow. (C) Sediment and woody debris deposition in an Elwha River floodplain channel at Rkm 5.4. (D) Fine woody debris on the intertidal beach of the delta ~200 m east of the river mouth during low tide. Photos provided by Neal and Linda Chism of LightHawk, Vivian Leung of University of Washington, Amy East of USGS, and Jeff Duda of USGS.

In addition to the transport of sediment in the Elwha River system, an abundance of woody debris was exhumed from the reservoirs and transported downstream to the river and coast (Fig. 14). This wood was derived from a number of sources, including erosion of forested subaerial banks in the Lake Aldwell delta and exhumation of pre-dam stumps and woody debris from sediments of the former reservoirs (Fig. 14). The new supplies of wood added complexity to the river within the former reservoirs (Fig. 14A, B) and the fluvial and coastal landforms downstream of the dams (Fig. 14C, D). This included coarse

during the first two years of dam removal as discussed in detail below (cf. Fig. 14A, B; Randle et al., 2015-in this issue).

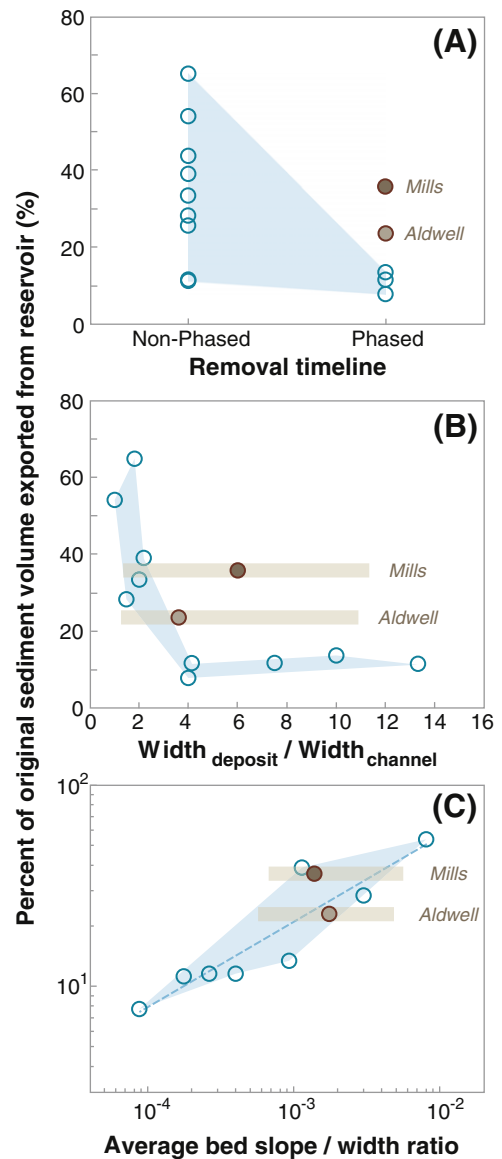
Fig. 15. Comparison of sediment export parameters from previous dam removals by Sawaske and Freyberg (2012) (blue symbols and shading) and those from dam removals on the Elwha River (brown symbols and shading) during the first two years of removal. The blue shading for the previous projects shows the range of values existing from these studies. The brown shading for Lakes Mills and Aldwell in (B) and (C) represents the range of channel widths measured during the dam removals, and the symbols are plotted for average channel width values. The dashed line in (C) is the nonlinear regression from the previous authors' work. See text for further descriptions.

Additionally, we found that the Elwha River channel width through the former reservoirs varied by almost a factor of 10 during the two years studied, and maximum channel widths were measured to be 340 and 220 m in Lake Mills and Aldwell, respectively. During higher flows and times of rapid sediment redistribution in the reservoirs, the Elwha River could essentially fill the entire reservoir deposit width in sections of each reservoir (e.g., Fig. 4). Thus, the average channel widths of 75 m through the Elwha River reservoirs do not represent the potential for sediment export expressed in the variables of Sawaske and Freyberg (2012; filled symbols, Fig. 15B). However, the Elwha River data may be consistent with Sawaske and Freyberg's (2012) synthesis if the highly variable nature of channel widths in these former reservoir systems is considered (shading, Fig. 15B).
