Arcata Fisheries Technical Report TR 2018-31

Trend Analysis of Salmon Rearing Habitat Restoration in the Trinity River at Summer Base Streamflow, 2005-2015

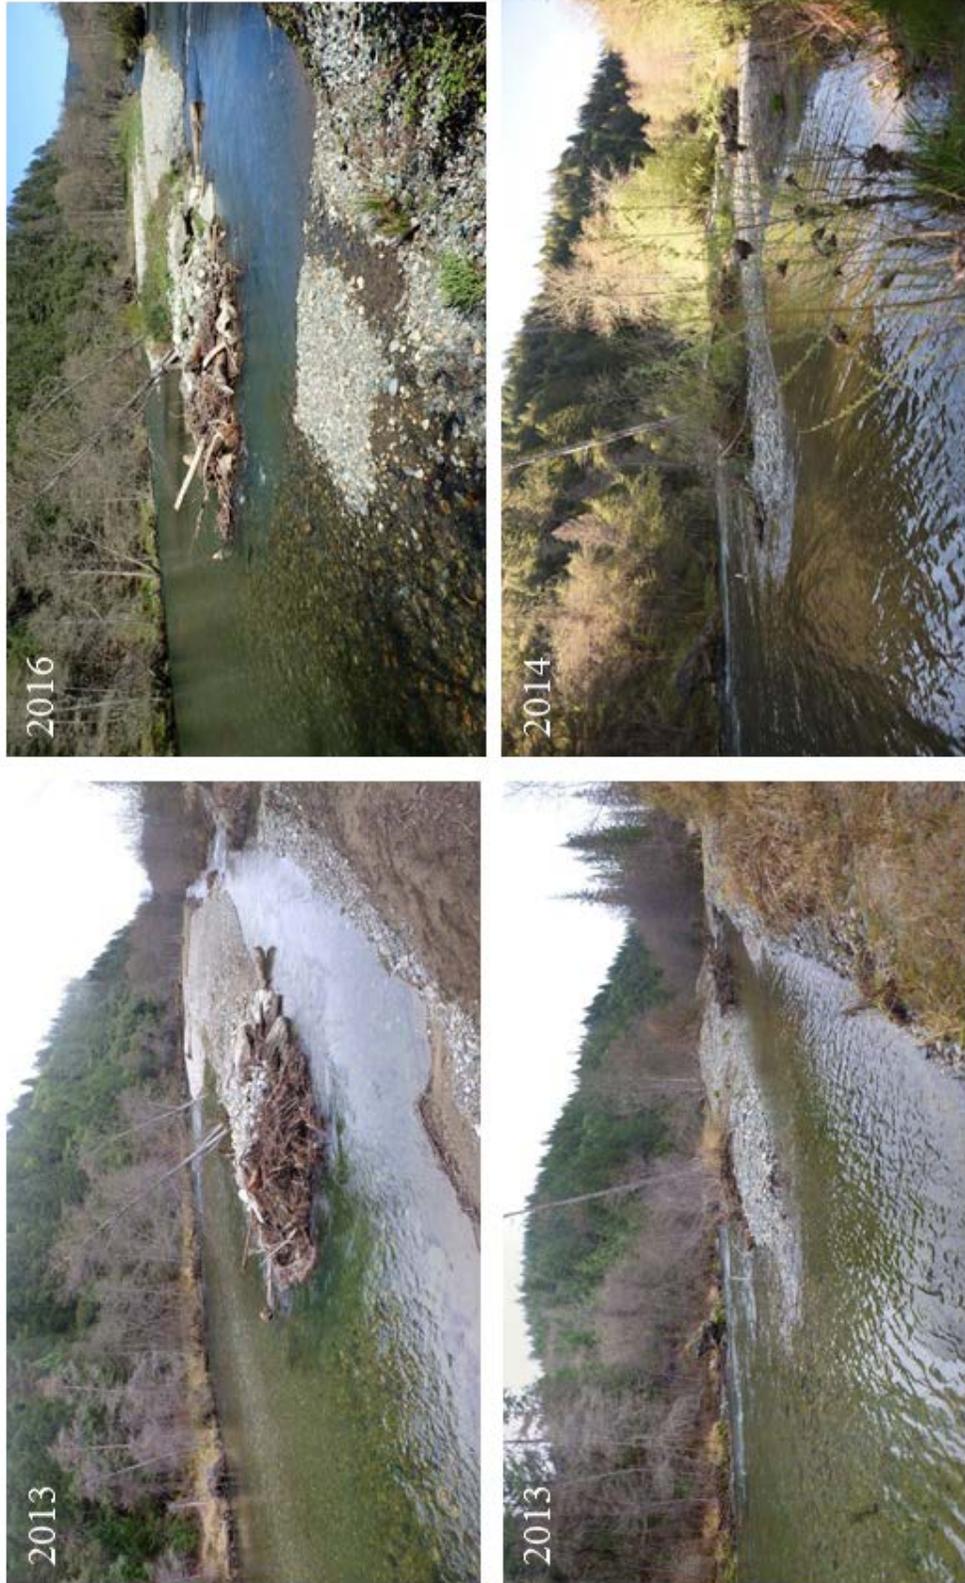
Figure 8. Photographs documenting the effect of hard points on fluvial processes at two side channels constructed at Lower Steiner Flat. The upper panel documents a side channel with a constructed large wood jam or hard point soon after construction in 2013 and again in 2016 after scouring streamflow events. The lower panel shows a second side channel soon after construction in 2013 and again the following year documenting closure due to sediment deposition.

Channel changes at other rehabilitation sites included the evolution of off-channel features. Lower Steiner Flat included two low flow side channels with alcoves at the downstream end of each, as well as, a separate alcove at the downstream end of a high flow side channel (CH2MHill 2011). The designers correctly predicted that, in the case of aggradation at the upstream low flow side channel, its corresponding alcove would continue to provide habitat benefits. We observed a complex interaction of side channel and alcove evolution that resulted in the aforementioned constructed side channel closing in 2015 (Figure 8), a constructed alcove contracting and growth of a natural side channel. Overall, total rearing habitat increased and optimal habitat decreased between the post-construction survey in 2013 and the most recent survey in 2015 (Appendix A, Figure A-5). During this interval, we documented a steady reduction in the surface area of the constructed alcove in our sub-sample which partly explains the reduction in optimal habitat. Visual inspection of a time
