Scott River Watershed Restoration Strategy & Schedule

**Prepared by
the Scott River Watershed Council
&
Siskiyou RCD**

Revised January 2014

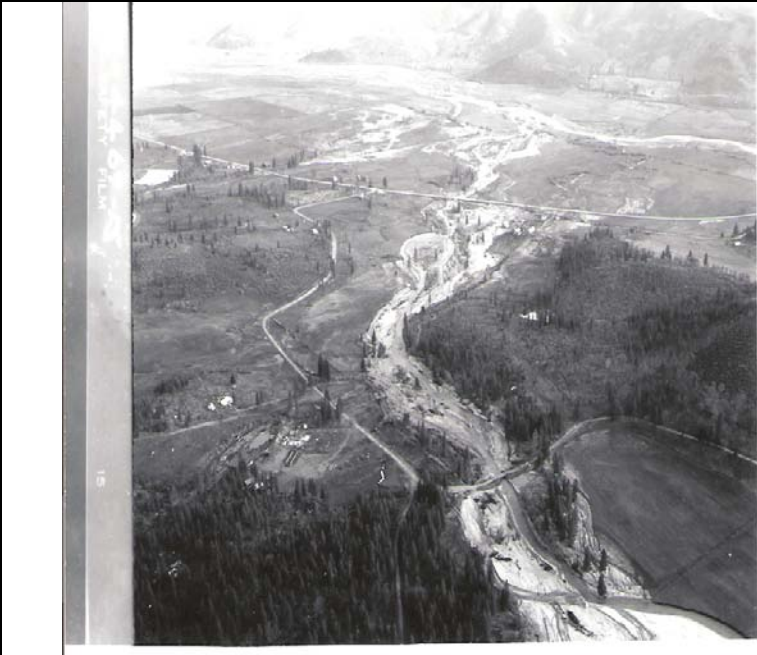
February 1965 Looking downstream at the mouth of French Creek following the 1964 flood.

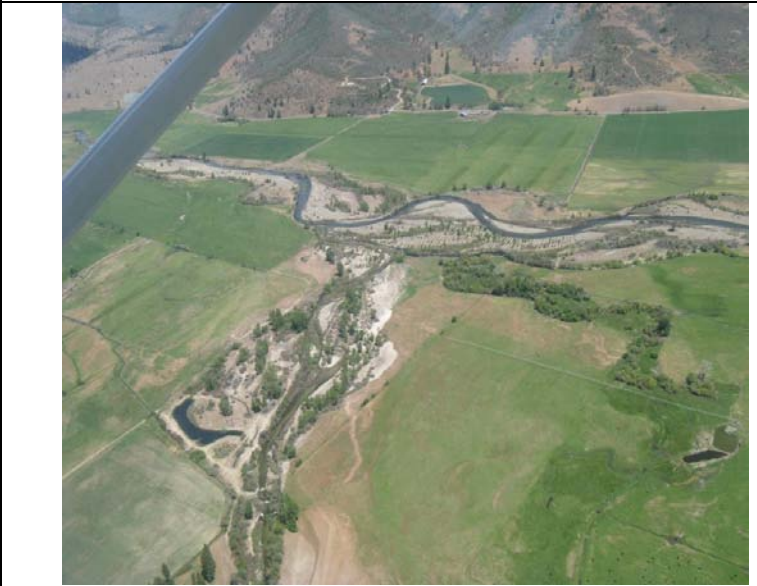
May 2008 Same location as above, following extensive riparian planting and fencing beginning in the late 1990's.

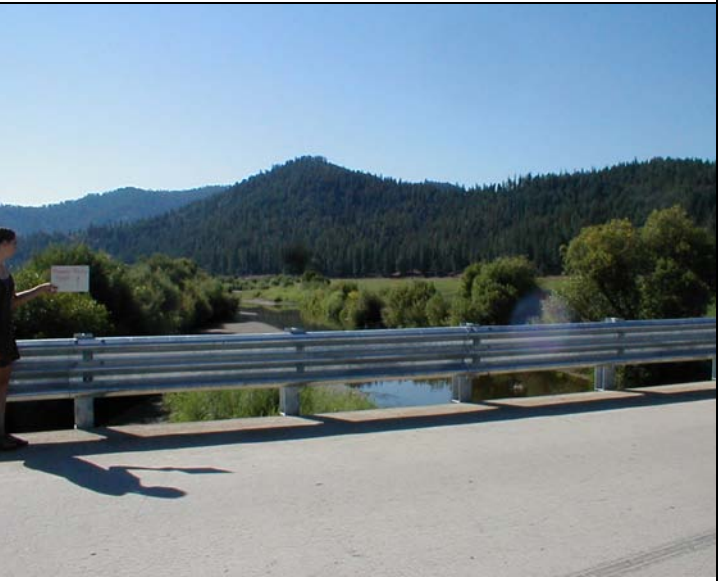
| | <p data-bbox="1015 949 1193 982">July 28, 2004</p> <p data-bbox="1015 1039 1388 1176">Scott River same location as above, USGS Flows recorded at 39 cfs</p> |

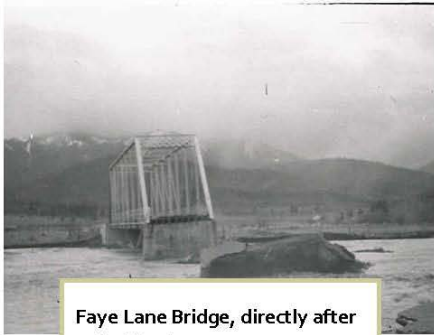
The following images were taken from the Fay Lane Bridge, looking North toward Fort Jones. Note the appearance of vegetation in the lower Right Hand corner.

Faye Lane Bridge, directly after 1964 Flood

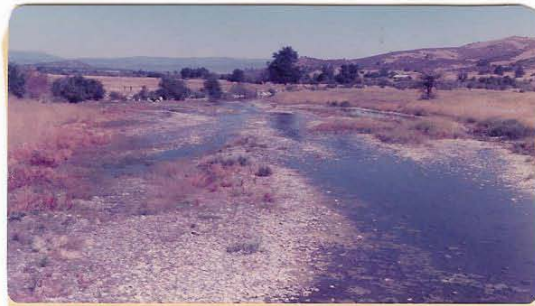
Looking North, 1977

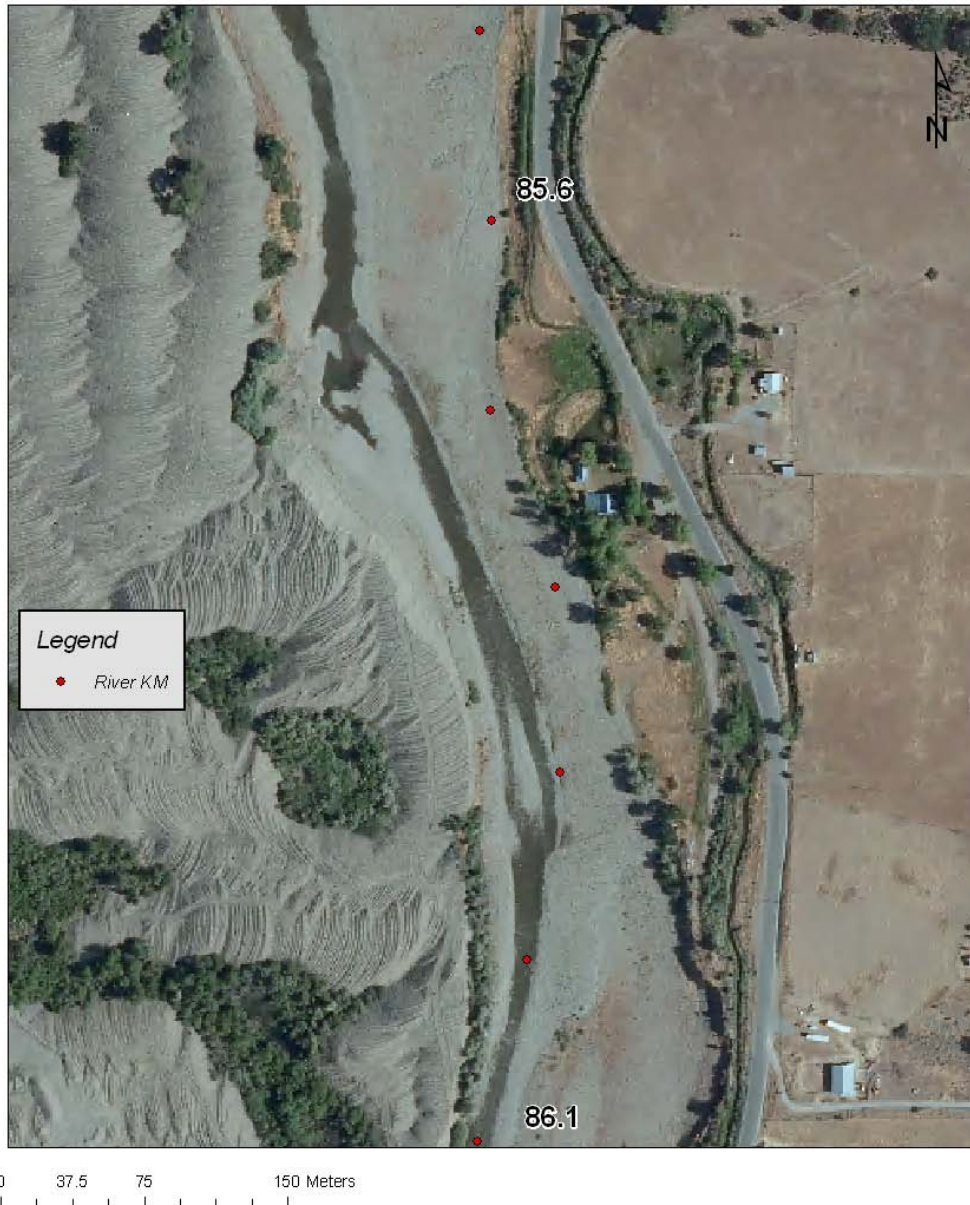
RKM 86.1 - 85.5 - NAIP 2010

Figure 4. Section of the Callahan tailings

The 2,500 foot segment shown in Figure 4. located at the downstream end of the tailing reach, was restored to a wider channel and flood plain in 2007. This reach is located where the tailings piles begin to taper off and open up to a wider channel. This lower portion of this reach has some potential to establish a riparian corridor. **See Appendix C for cross-section information.** However, the substrate in this reach is extremely large cobble with little to no fines present. The reach is very hot and dry, and the river goes

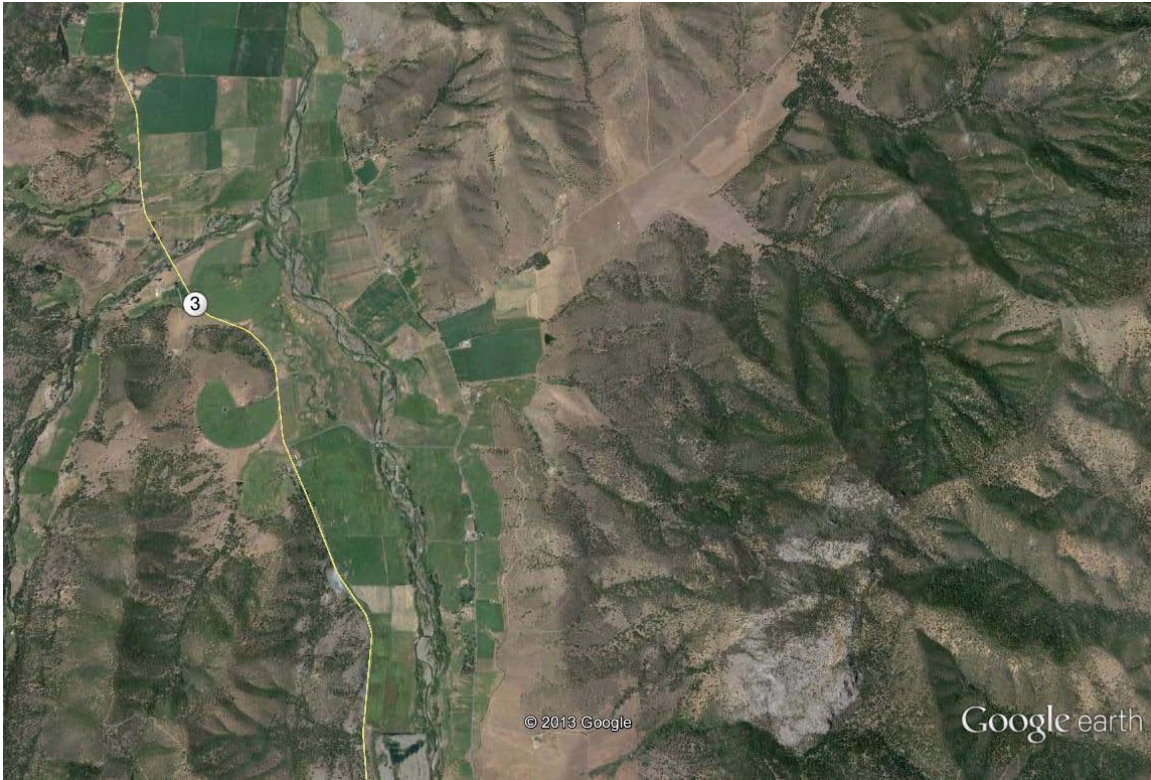
Figure 5 . Reach II. French Creek is seen entering the Scott River Center left of image.

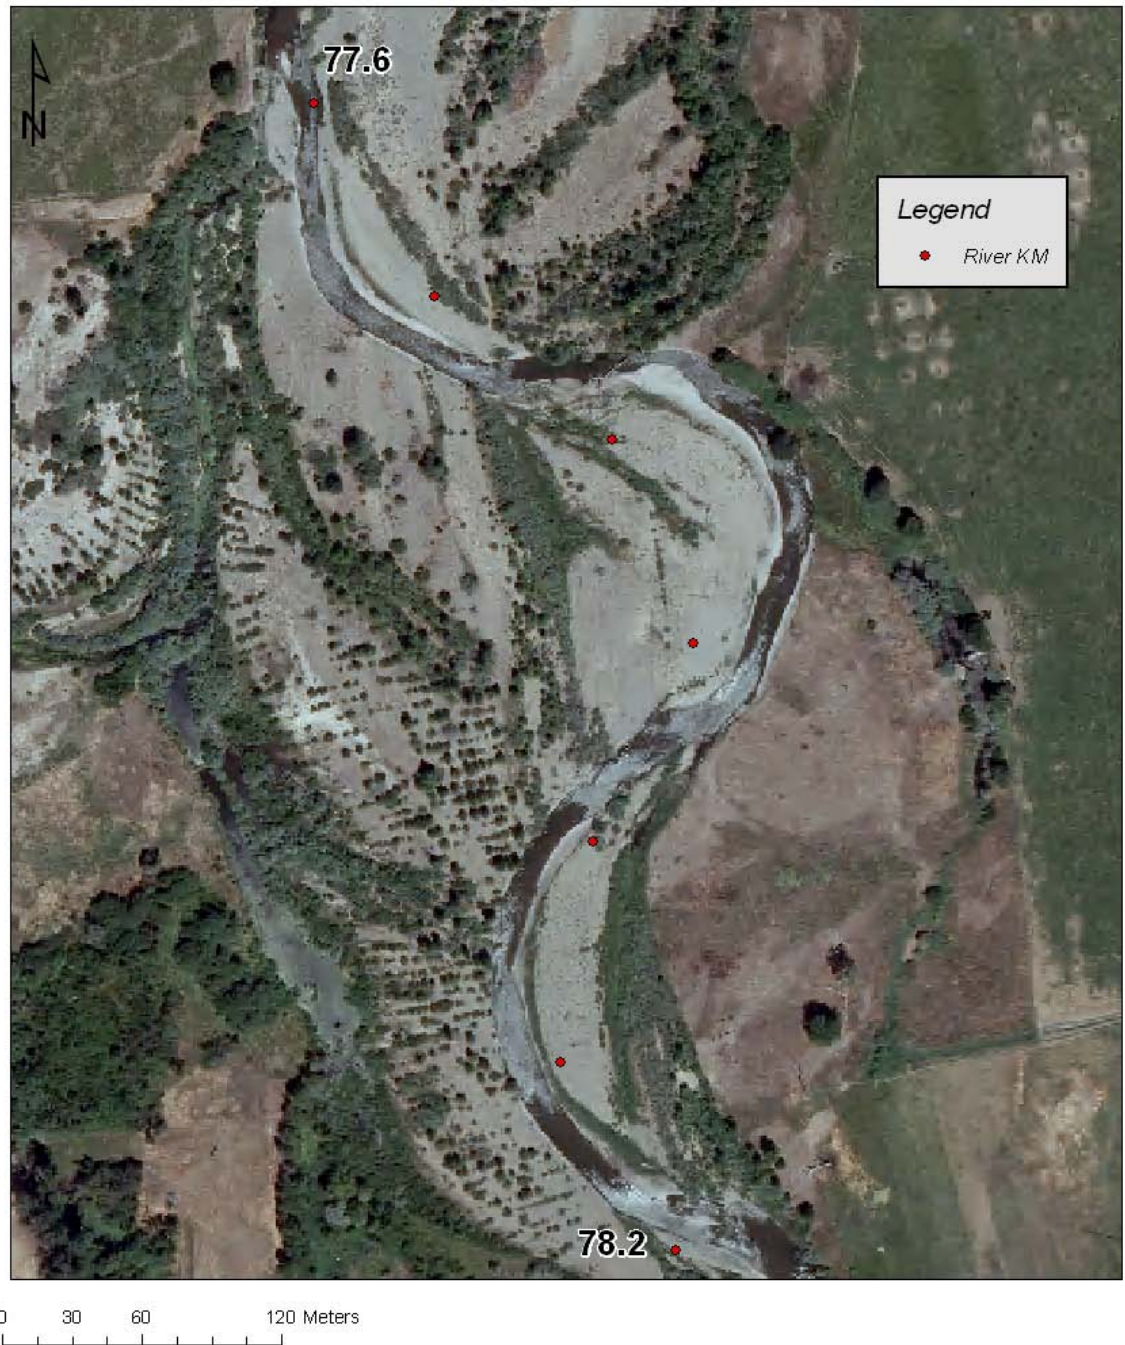
RKM 78.2 - 77.6 - NAIP 2010

Figure 6: Scott River vicinity of French Creek (Middle left of image) and Wolford Slough(bottom left quarter of image) Lidar 2010

Planting rows visible in Figure 6 were planted in 1997 as part of the Fay Lane Project. These plantings are some of the most successful in the Scott River, both in terms of vigor and survival.

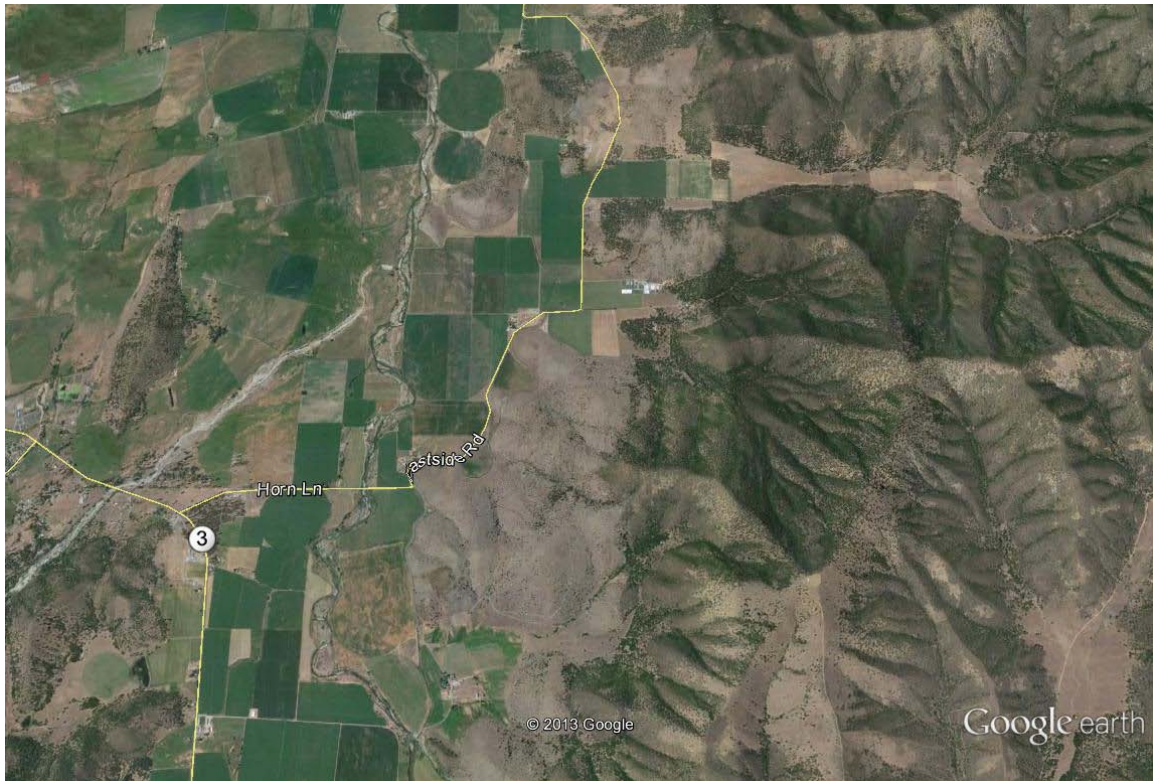
Figure 7. Reach III Google Earth Imagery July 2012.

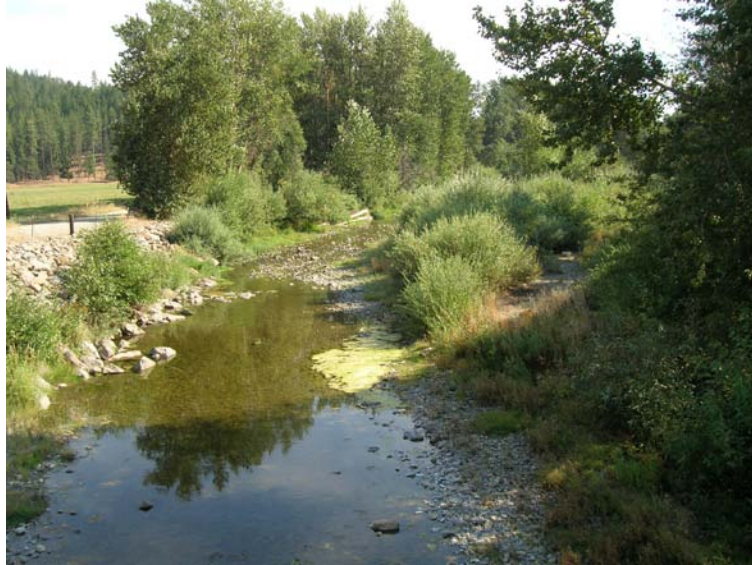
Riparian vegetation in lower Shackleford Creek.

Shackleford Creek has two alluvial reaches, the first is in the lower ½ mile at the confluence with the Scott River, and the other reach is on Quartz Valley Indian Reservation, upstream from the Quartz Valley Rd Bridge. (See Figure 14.) Other than those dry reaches, Shackleford Creek maintains perennial flows, suitable water temperatures for salmonids, and complex rearing habitat. The existing riparian condition is adequate, and many locations have undergone natural recruitment following exclusion fencing. Site specific replanting would be effective in the lower sections of Shackleford Creek. It is not clear at this time if the alluvial reaches that currently go sub-surface can be returned to perennial flow. The substrate in these reaches is large rock and cobble dominated and not likely to support riparian replanting.

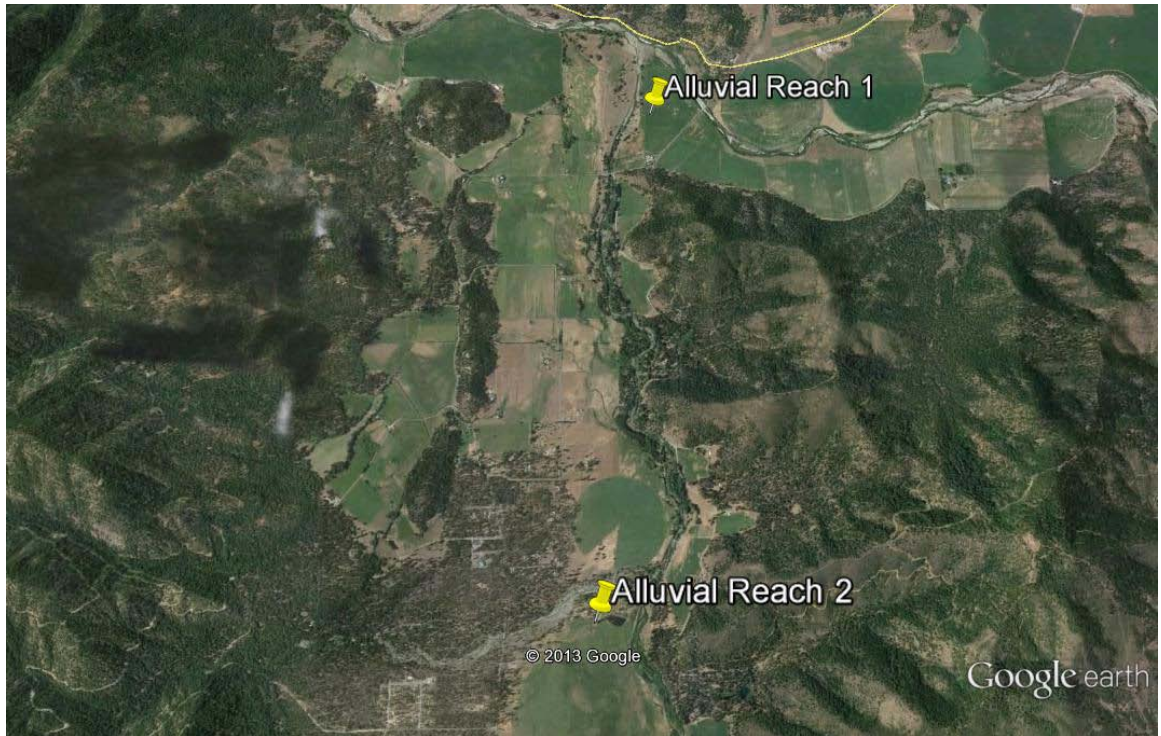
Figure 14 Lower Shackleford-Mill Creek

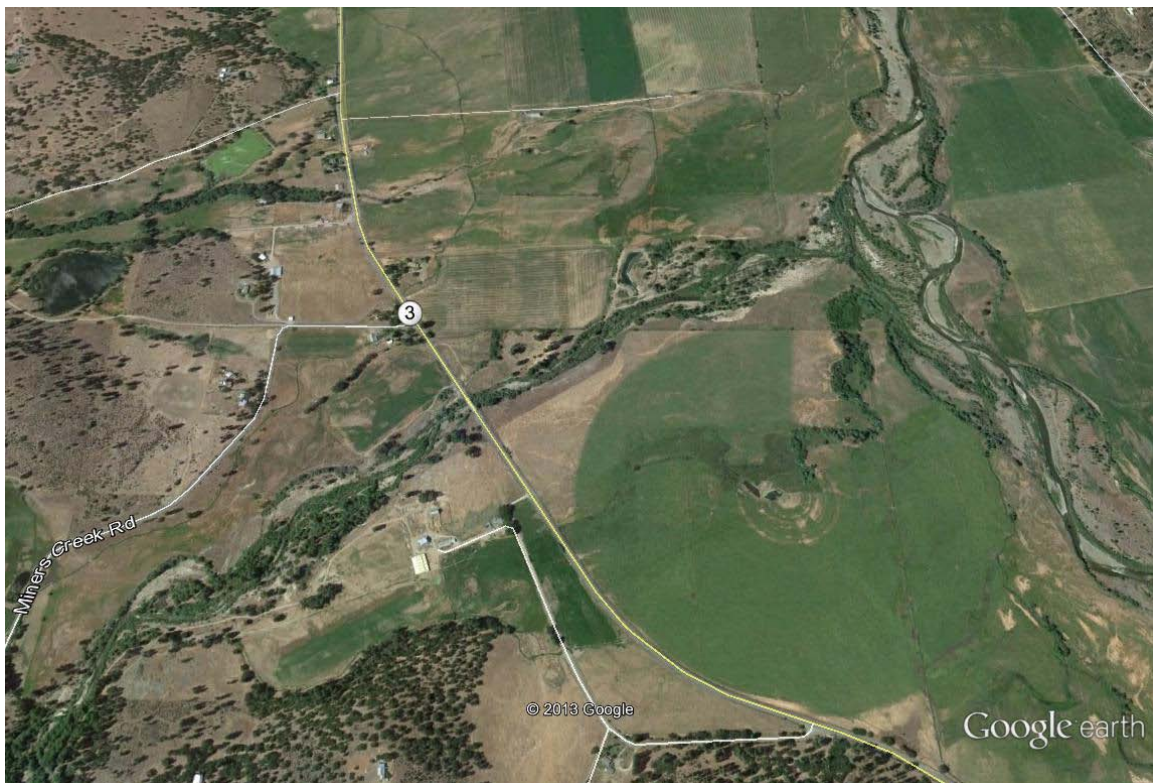
Figure 16. Scott River at the confluence with French Creek.

Beaver play an important role in the riparian ecosystem of French Creek and the mainstem Scott in the vicinity of French Creek. The dam building in this area likely contributes significantly to an elevated groundwater table. Plantings implemented in the Scott River in the vicinity of French Creek have been some of the most successful in the watershed.

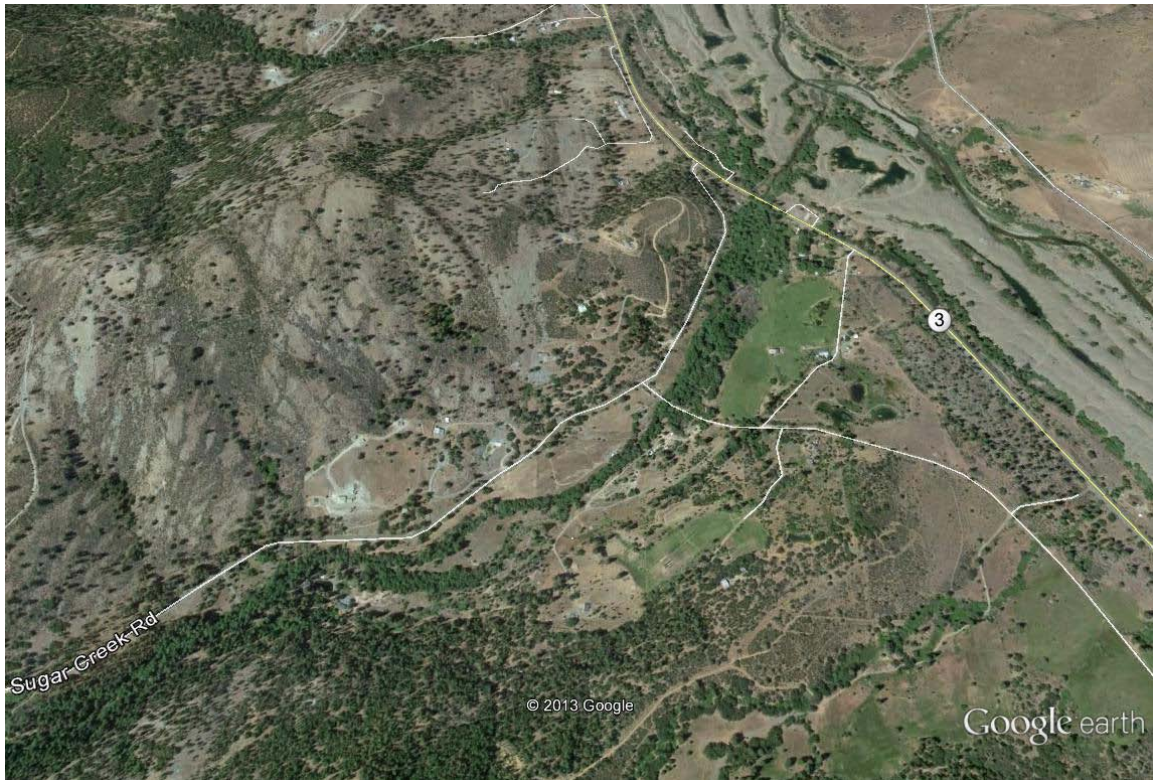
Figure 17. Sugar Creek.

Sugar Creek has no alluvial deposition section, and flows year-round. Sugar Creek has an active beaver population in the lower ½ mile, contributing to water storage and salmon habitat. The riparian canopy in Sugar Creek is mature, and provides sufficient shade to the creek. The combination of canopy, aspect, and snow-melt keep the water in Sugar Creek at an average of 16-18°C in the summer. At this time riparian replanting is not needed in Sugar Creek. However, some landowners have identified a need to protect key trees from beaver damage. This protection will be done on an as needed basis, with some tree caging beginning in 2013.
